J Fail. Anal. and Preven. (2019)

DOI 10.1007/s11668-019-00619-9

Failure Analysis of Secondary Superheater Tube in a 600-MW Coal Power Plant

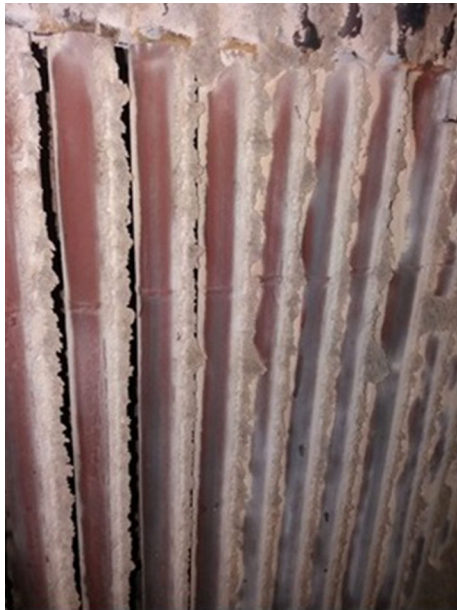
Fig. 1 Secondary superheater tubes in installed condition taken from the manhole

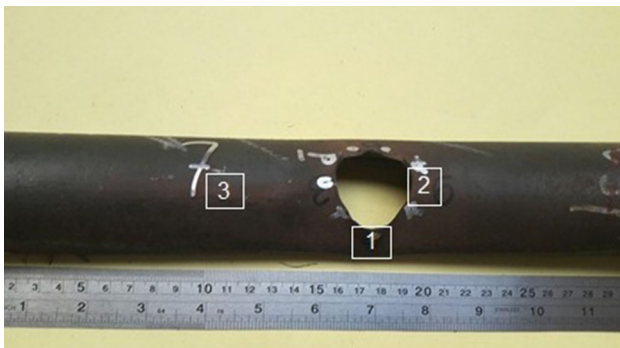
Failure analysis was performed on the failed (leaked) tube. The investigated tube is shown in Fig. 2, and visual inspection was carried out around the lip rupture. For detailed analysis, the failed tube was cut along the cross section and some microstructure/hardness samples were collected from different locations (numbers 1, 2 and 3 in Fig. 2).

Fig. 2 Cross section of the failed tube (the numbers indicate the location of samples)

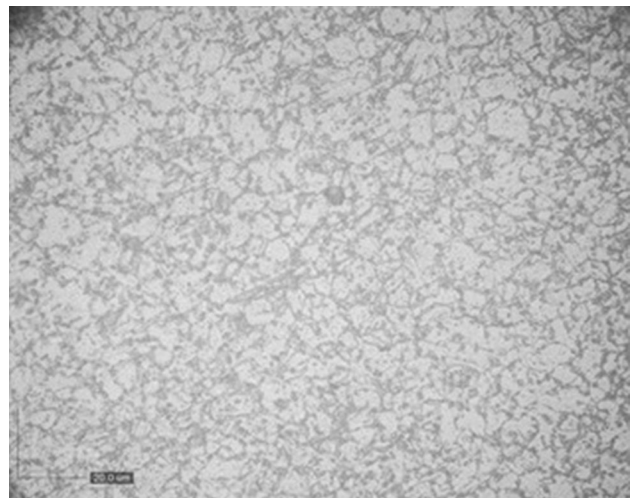
Fig. 3 An optical image of microstructure taken 500 mm away from the thin-lip rupture

Based on the aforementioned data, it can be concluded that the steel of the failed tube is in good agreement with the standard of ASTM A213 T91. The steel has been used widely for power plant application and has very good creep strength and good resistance to oxidation [9, 10]. Hence, failure owing to faulty chemistry of the steel is ignored.

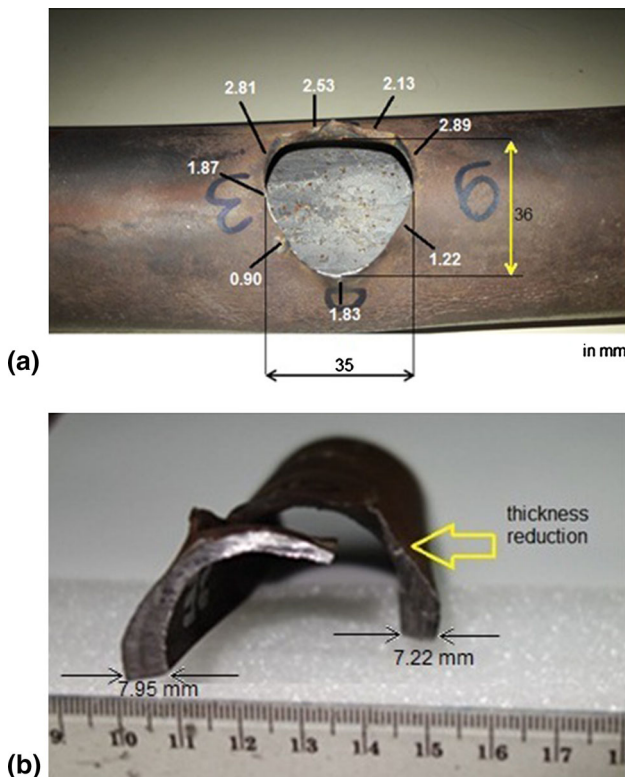
Visual inspection on the failed secondary superheater tube in Fig. 4a exhibits that the tube had a sharp edges and thin-lip rupture in the dimension around of 35 mm length and 36 mm width. The wall thickness measurement on the edge rupture shows the thickness reduction did not occur uniformly and the wall thickness was in the range 0.90–2.89 mm or 65–88% of the original wall thickness. The color around the lip rupture was light brown pertaining to superficial iron oxides. There is a change in color because during the operation the tube interacted with an extreme environment where steam flowed inside of the tube and the outside of the tube was exposed to flue gas (hot gas). No material loss was observed at the inner surface of the tube in Fig. 4b, which indicated that the thinning of the failed

Fig. 4 (a) Failed tube suffered a thin-lip rupture (white numbers indicate the thickness). (b) Cross-sectional cutting of the failed tube shows that reduction in wall thickness started from the outer wall

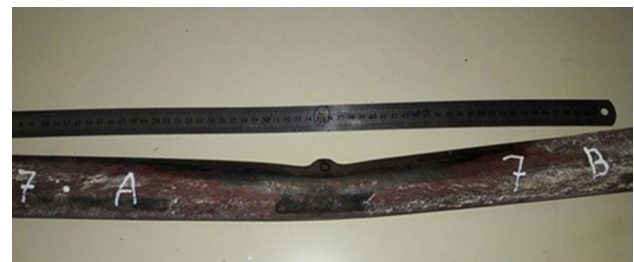
Fig. 5 Failed tube experienced plastic deformation (bowed shaped)

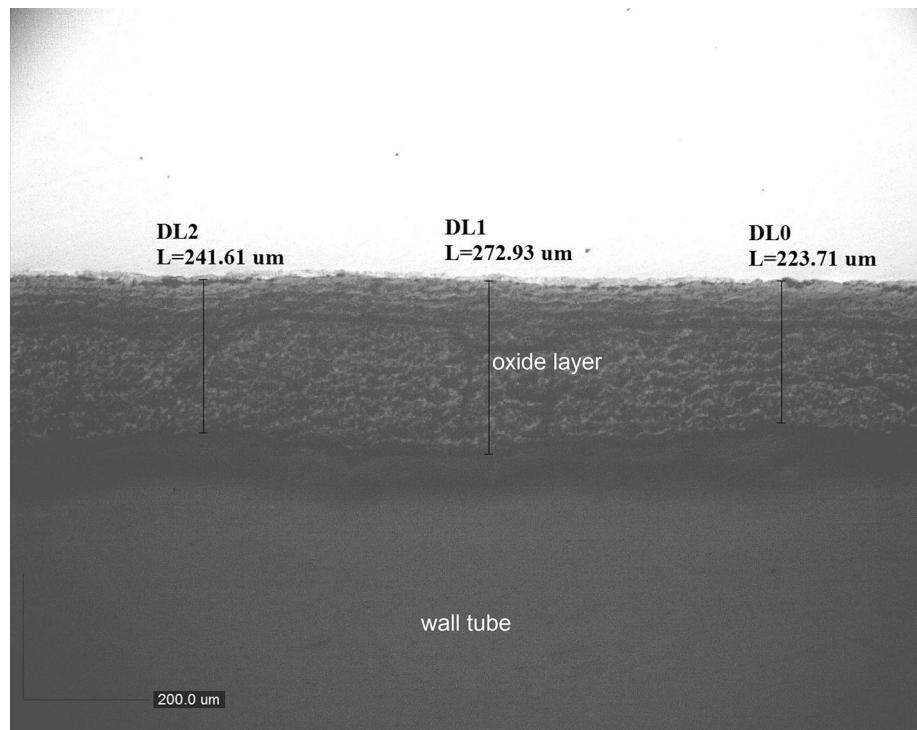
A SEM micrograph of inner surface of the tube wall in the opposite side of the lip rupture is shown in Fig. 6. As can be seen, the tube had adherent nonuniform oxide scale layer with the thickness ranging from 0.223 to 0.272 mm that formed during the long-term operation. As the oxide layer is very thin, it will not block the flow of steam; hence, it is believed that the tube failure occurred due to factors outside of the tube wall.

Fig. 6 Thickness of the thin adherent oxide scale layer at the inner surface in the opposite side of the lip rupture

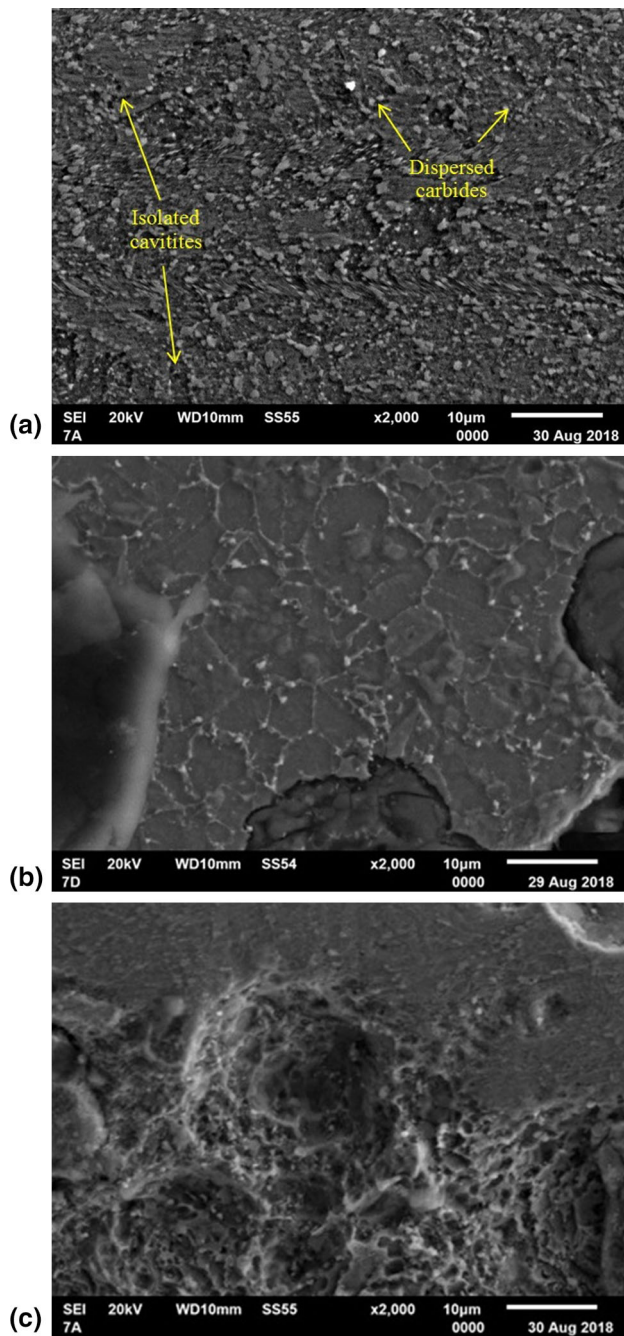
A SEM image in Fig. 7a (the location of sample number 3 in Fig. 2) shows dispersed carbides and the presence of some isolated voids, which indicate creep damage. Furthermore, the microstructure on the lip rupture in Fig. 7b (the location of sample number 2 in Fig. 2) reveals that the long-term service in high temperature caused the carbide appearance to become spherical particles in a ferrite matrix and the void had been interconnected and formed a crack. The presence of some isolated voids and coarse carbides is related to overheating [1, 11] and creep damage. In addition, ductile fracture was also observed in the failed zone as seen in Fig. 7c (the location of sample number 1 in Fig. 2), which strengthens the evidence that the material had experienced softening and overheating.

Fig. 7 (a) A secondary electron of the SEM image shows dispersed carbides and isolated cavities. (b) A secondary electron of the SEM image shows coarse carbides near the lip rupture. (c) A secondary electron of the SEM image shows a typical dimpled-rupture fracture surface

The turbulence that occurred in the localized erosion area resulted in the accumulation of heat and led to overheating. It must be noted that the rate of heat transfer in the outer wall with slag deposits was lower than the area which was not covered with slag deposits. This condition caused the outer surface of the tube wall temperature on the area covered by slag deposits to be decreased and the outer surface of the tube wall that was not covered by slag deposits to be increased. The localized rapid overheating beyond the operating temperature drove the flow of material and softened the tube wall. Due to the localized wall thinning and softening of the tube, the tube was unable to withstand the hoop stress with the result that the tube was bent or had a bowed shape (see Fig. 5) leading to a failure due to overloading [1] and resulting in ductile fractures as shown by dimple rupture (see Fig. 7c).

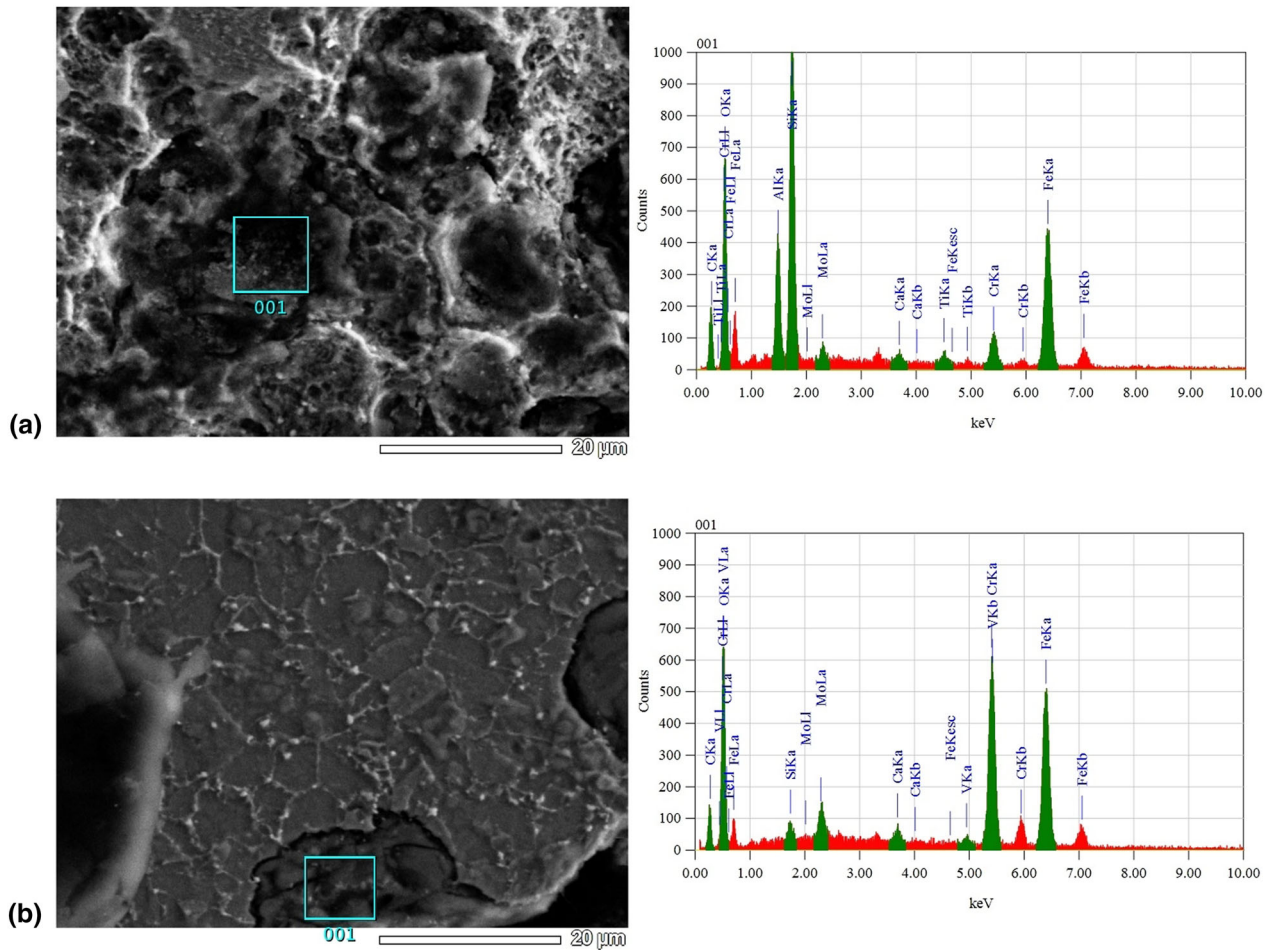
To support the data, SEM-EDS analysis was carried out on the outer surface of the tube wall near the lip rupture. The result of SEM EDS in Fig. 8a shows the EDS spectra of inorganic elements, i.e., Si, Ca, Al, Fe, Ti and V, which contributed to the formation of slag deposits [12]. The presence of those inorganic elements is also supported by fly ash content analysis which evidences the content of TiO_2 as 0.58%, Al_2O_3 as 15.43% and Fe_2O_3 as 12.64%. Fly ash content analysis also detected the presence of Na_2O with the amount of 1.84%. It could be determined that those elements came from the fuel and coal being used in the combustion [13], which might relate to poor and incomplete fuel combustion conditions. It must be noted that the existence of certain inorganic elements in coal such as Si, Ti, V and Na would decrease the ash fusion temperature. SEM-EDS quantitative data of Fig. 8a in Table 1 show the

presence of corrosive elements (Si and Ca) is below 20% mass (see Table 1) which suggested that the corrosion attack had occurred and was caused by the fusion of ash particles [14]. The spectrum of vanadium was also detected by SEM-EDS analysis as shown in Fig. 8b. The presence of vanadium with the amount of 0.75% mass (see Table 2) caused corrosion due to the formation of V_2O_5 which has a melting point of 690 °C [15, 16].

Fig. 8 (a) EDS spectrum taken near lip rupture (the location of sample number 1 in Fig. 2). (b) EDS spectrum taken near lip rupture (the location of sample number 2 in Fig. 2)

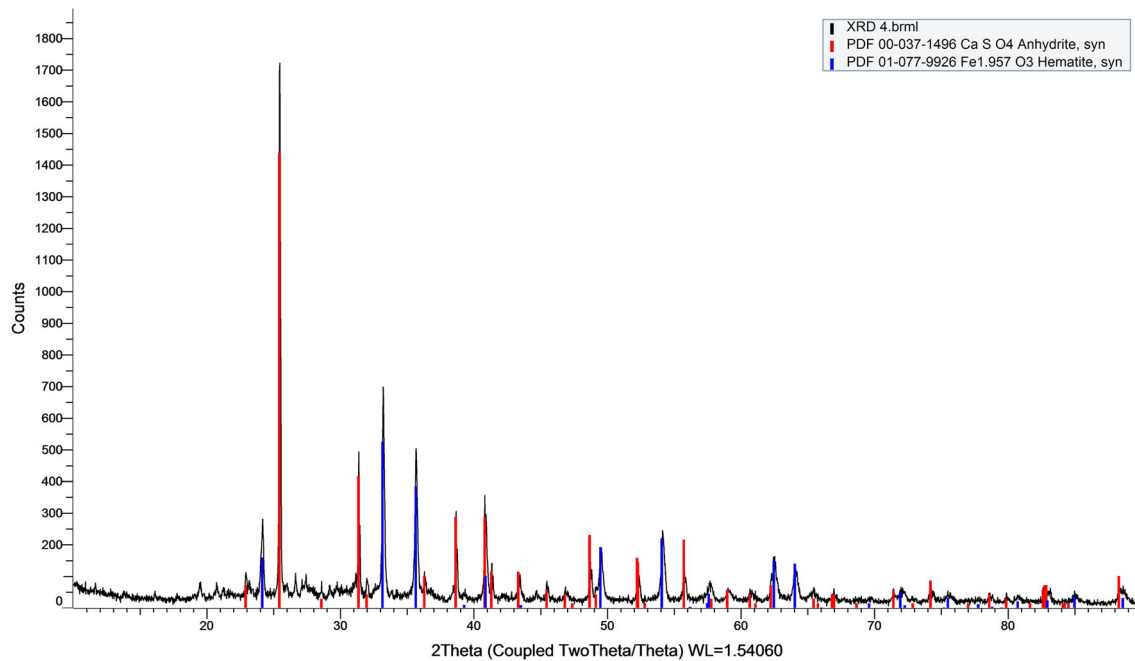
Slag deposits identification taken from outer wall of the tube was conducted using x-ray diffraction, and the results are presented in Fig. 9. The results obtained from XRD in Fig. 9 identified that deposits consist of alkali sulfate compound ($CaSO_4$) and corrosion products (iron oxides), which evidence the failed tube had suffered corrosion attack. The compound $CaSO_4$ caused coal/fly ash corrosion on the interface of scale/metal tube with a temperature range of 566–732 °C. The compound with low melting point formed molten flux at operating temperature and eliminated oxide layer which led to the tube being exposed. Overtime, metal tube continued to be consumed and a reduction in wall thickness caused it to be nonuniform and damaged. Therefore, it is evident that coal/fly ash corrosion occurred and started with an

Fig. 9 Characteristic of x-ray diffraction spectrum from slag deposits shows the presence of CaSO_4 and iron oxides

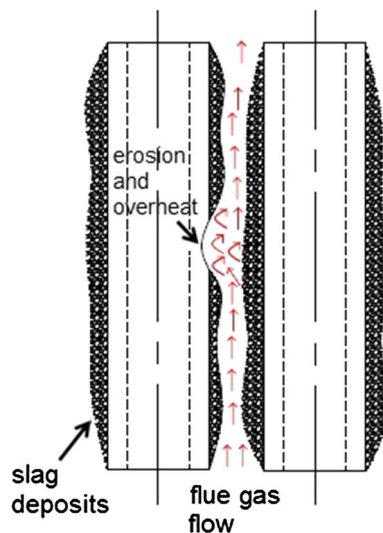
From the evidence, failure mechanism in secondary superheater tube can be explained further using the following illustration of superheater tube with slag deposits on the outer wall of the tube as shown in Fig. 10.

Flue gas flow upward between the two tubes with slag deposits in the outer wall (see Fig. 10). Slag deposits caused the flue gas flow to be nonuniform where the flow which went through the slag deposits was slower. As the volume of the flue gas stayed the same, the flow

which went through areas free of slag deposits became faster and led to turbulence. This then caused localized erosion on the outer wall surface and decrease in thickness nonuniformly in the affected area significantly.

In this case, although corrosion attack had occurred and creep damage was observed, they did not contribute significantly to the main failure of the tube. Hence, it is concluded that the tube failed because of slag deposit formation on the outer surface of the tube wall, which resulted in two simultaneous mechanisms: localized flue gas erosion followed by rapid overheating.

It is clearly evident that the formation of slag deposits on the outer surface of the tube wall is the main cause of the tube failure. It was mentioned previously that the power plant was designed for coal with fly ash temperature of 1300 °C; however, the result of ash fusion temperature test shows that the power plant used coal with fly ash temperature of 1100 °C. The low ash fusion temperature of the used coal was due to the presence of inorganic trace elements as proven by SEM EDS analysis and fly ash content analysis of the slag deposits. If ash fusion temperature is low, ash particles can easily fuse and adhere to the outer surface of the tube wall, forming larger particles and finally causing the slag layer to grow thicker.

Fig. 10 Illustration of failure mechanism on superheater tube with scale on the outer wall of the tube

- Carry out regular check on air-to-fuel ratio in order to avoid any excess air which can cause incomplete combustion in the superheater.
- Use coal with the required ash fusion temperature.
- Soot blowing must be carried out periodically and properly according to the manual procedure to remove slag deposits from the tubes.
