# Trouble Shooting Turbine Blade Damage In 55 Mw Geothermal Power Plant

**Abstract**—In 2013, there was 55 MW geothermal power plant experienced a damage on 3<sup>rd</sup>-stage turbine blade due to broken tenon head caused by corrosion fatigue. Since this was a major disruption affecting business and operational performance of the plant, a quick recovery plan was required to put the plant back online while long term action plan was also prepared to improve the existing design in order to prevent the re-occurrence of the same failure mode that will be executed on the next overhaul schedule.

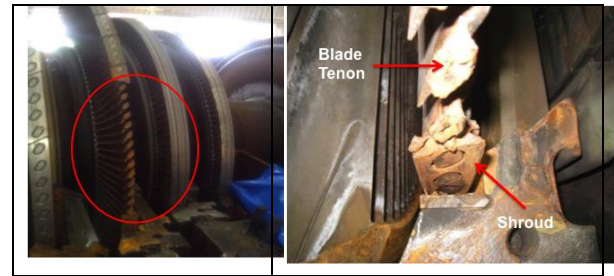
- Five adjacent segments of rotor shroud of x-stage turbine blades were broken and apart from their tenons (Figure 1)
- Outer labyrinth that is paired with the 3<sup>rd</sup>-stage turbine blades suffered severe damage due to rubbing against the damaged shroud.

Figure 1 Damage of 3<sup>rd</sup> stage turbine blade and Shroud

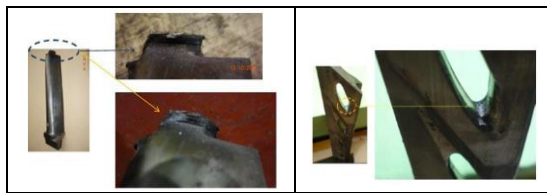
- Worn-out and broken blade tenon head detached shroud during operation
- Erosion on the blade tenon head and shroud due to steam impurities
- Fatigue crack on the blade tenon head that subject to cyclic loads

Figure 2 Wornout and broken blade tenon head and shroud

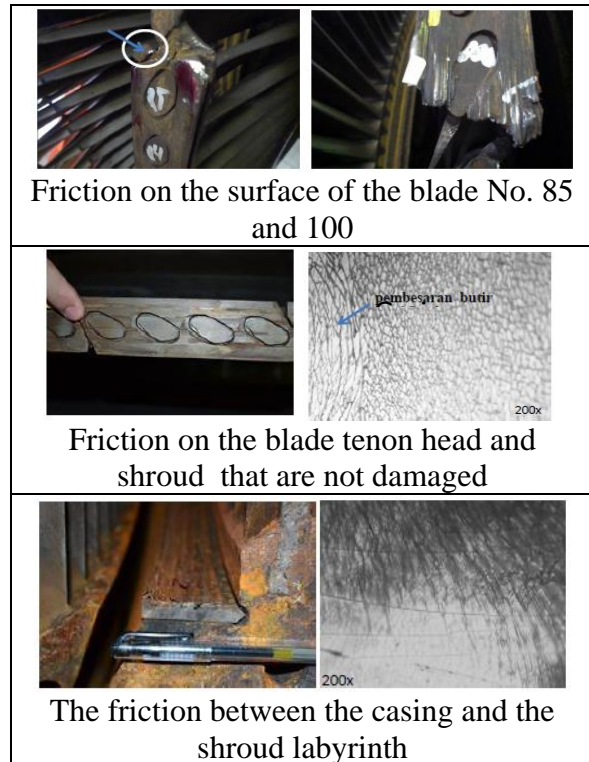
Fractography and in-situ metallography analysis on the shroud fracture surface reveal enlarged grain diameter (Figure 3) adjacent to the shroud that indicates the area has experienced overheating as a result of severe friction between the shroud and the labyrinth. The presence of damage on the labyrinth of stage 3, highly broken-deformed shroud due to high temperature and frictions on the surface of the shroud and blade tenon head that did not fail justify that analysis result.

Figure3 Friction on blade tenon head, shroud and labyrinth

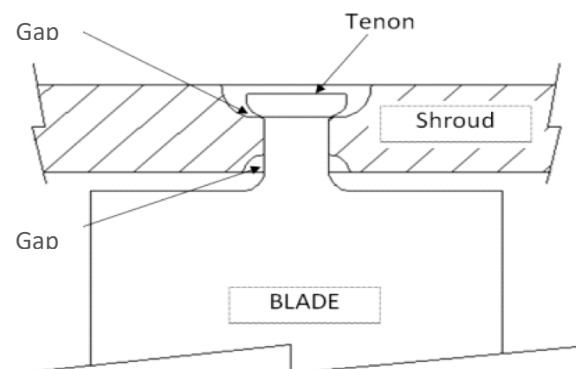
In the existing 3<sup>rd</sup>-stage turbine blade design (Figure 4), there is discontinuity volume between blade tenon head and shroud that is fastened with the process of hot irreversible plastic deformation (rivetting) during the initial blade assembly process. This design creates a gap between the shroud and tenon head and becomes local stress concentrations which are prone to corrosion attack that is justified by fractography analysis results that showed the occurrence of cracks and corrosion (Figure 5).

Figure4 Existing 3<sup>rd</sup> stage turbine blade design

There are several designs of the shroud which utilize rivet or integral shroud. Rivet with the square root section of the existing turbine design only suitable for ultra-light service. Punching process during rivetting and some flaw on the rivetting result create discontinuity volume between the blade and the shroud and generate stress concentration on the plate and blade tenon head which initiate the crack. In the design of integral shroud, shroud plate is an integral part of a turbine blade that is used for medium-heavy service (Nauman, 1982).

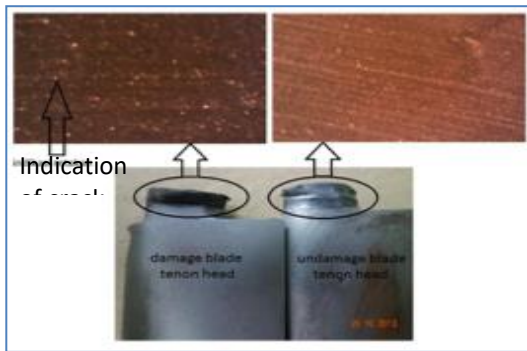
Figure 5 Crack on blade tenon head

and metallographic results showed corrosion on the surface of the shroud and blade tenon head. In addition to that, pitting corrosion and corrosion deposits is found on the bottom surface of the shroud and the joint area (figure 5 and 6) that have contact with blade tenon heads as an evidence of corrosion attack that area. This corrosion attack and cyclic load lead to dimensional changes in the blade tenon that enlarge the gap and the relative movement that cause abnormal vibration. The combination of corrosion, worn-out blade tenon head, the influence of the bending load (unsteady steam forces, rotor torsion, radial vibration, axial vibration), the plant start-up and shut down process and steam conditions (pressure and temperature) cause the blade tenon head failure due to corrosion fatigue (Mc.Closkey, 1999). The presence of impurity in the vapor can accelerate corrosion rate and fatigue of blade tenon. The worn-out blade tenon head and the shroud is then broken that cause the shroud to detach from the turbine

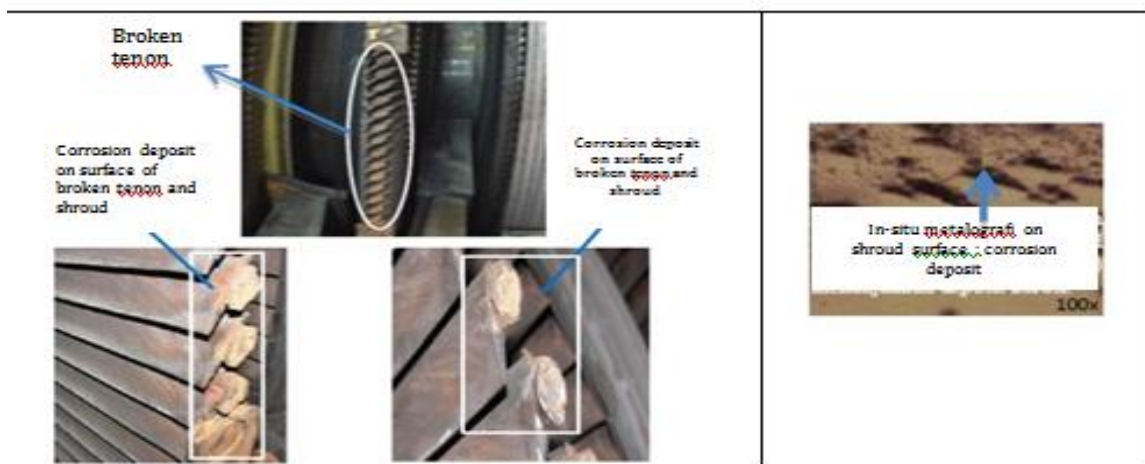
head found on the shroud broken part so that the upper surface of the shroud rubbing against the labyrinth experiencing great friction with labyrinth, blade which is justified by the indication of worn-out on overheating and subsequently ripped. shroud due to pitting corrosion and corrosion fatigue are typical of damage on steam turbine blade (Roberge, 2000), and has been widely reported in the literature / engineering paper (Mc.Closkey, 1999). Damage usually starts from localized corrosion caused by fretting, manufacturing defect, inclusion and pitting due to environmental factors such as the level of impurity steam, fault shutdown procedures, and the level of steam cation conductivity. A dewpoint lead the condensation process of the steam during shutdown process so that moist, liquid and oxygenated films formed on the surface of the blade and disc. A level of steam cation conductivity could accelerate that. Based on mechanistic models of corrosion fatigue, corrosive environments caused the vacancies as a result of dissolution phenomena on a metal surface (Mc.Closkey, 1999).

Image 5 Corrosion Tenon Blade Head

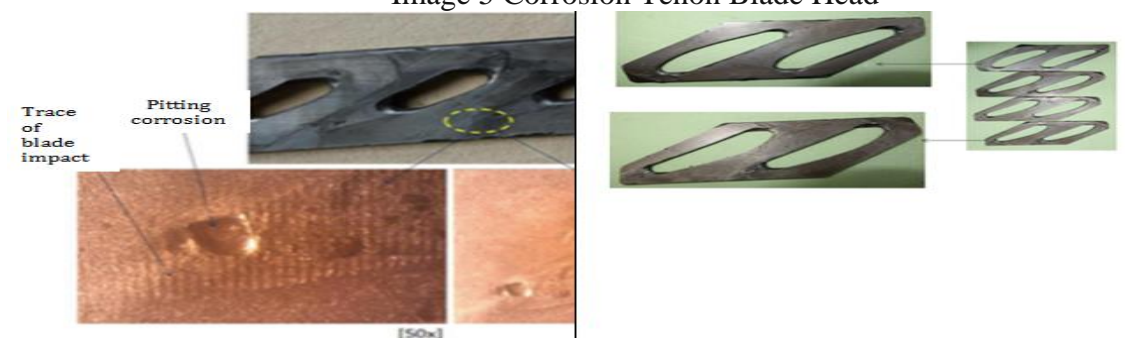
Figure 6 corrosion pitting on the surface of the bottom shroud

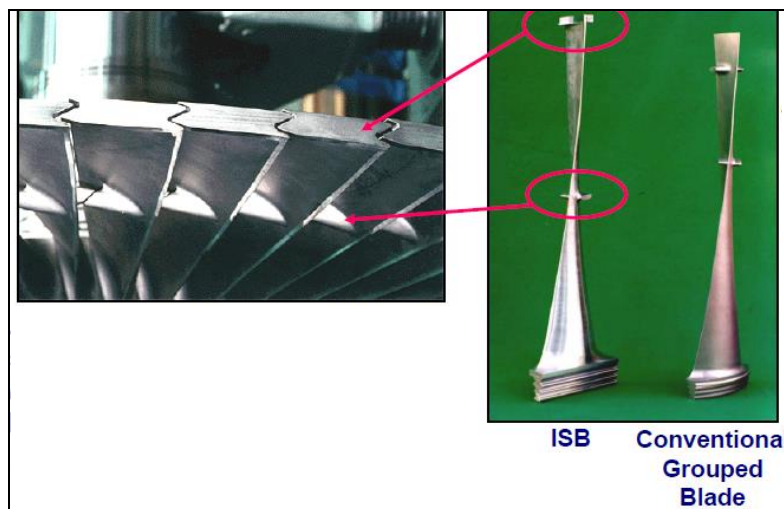
Figure 7 Integral Shroud Blade (ISB)

Turbine blades will be replaced with new design, Integral Shroud Blade (ISB) (Mitsubishi, 2009) (Figure 7). Its segment shroud has integrated profile with the blade so need no rivets or welding fastening process to reduce possibility of cracking due to residual stress, corrosion and fatigue. When the turbine reaches optimum operational rotational speed, shroud on adjacent blade will be aligned and strengthen themselves that give significant damping effect of the blade vibrations that reduce vibrations by 20% than conventional blade and increase blade reliability and corrosion fatigue resistance in corrosive environments of geothermal steam.

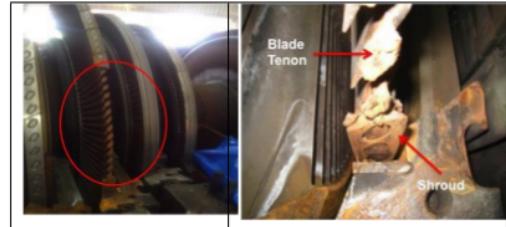
- Five adjacent segments of rotor shroud of x-stage turbine blades were broken and apart from their tenons (Figure 1)
- Outer labyrinth that is paired with the 3<sup>rd</sup>-stage turbine blades suffered severe damage due to rubbing against the damaged shroud.

Figure 1 Damage of 3<sup>rd</sup> stage turbine blade and Shroud

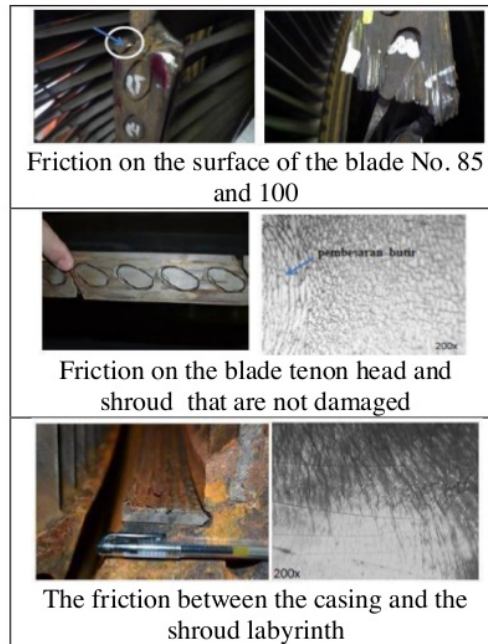
Fractography and in-situ metallography analysis on the shroud fracture surface reveal enlarged grain diameter (Figure 3) adjacent to the shroud that indicates the area has experienced overheating as a result of severe friction between the shroud and the labyrinth. The presence of damage on the labyrinth of stage 3, highly broken-deformed shroud due to high temperature and frictions on the surface of the shroud and blade tenon head that did not fail justify that analysis result.

Figure3 Friction on blade tenon head, shroud and labyrinth

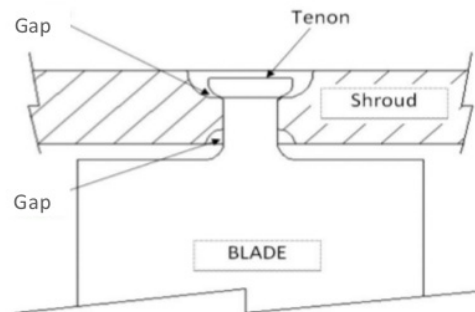
In the existing 3<sup>rd</sup>-stage turbine blade design (Figure 4), there is discontinuity volume between blade tenon head and shroud that is fastened with the process of hot irreversible plastic deformation (rivetting) during the initial blade assembly process. This design creates a gap between the shroud and tenon head and becomes local stress concentrations which are prone to corrosion attack that is justified by fractography analysis results that showed the occurrence of crack and corrosion (Figure 5).

Figure4 Existing 3<sup>rd</sup> stage turbine blade design

There are several designs of the shroud which utilize rivet or integral shroud. Rivet with the square root section of the existing turbine design only suitable for ultra-light service. Punching process during rivetting and some flaw on the rivetting result create discontinuity volume between the blade and the shroud and generate stress concentration on the plate and blade tenon head which initiate the crack. In the design of integral shroud, shroud plate is an integral part of a turbine blade that is used for medium-heavy service (Nauman, 1982).

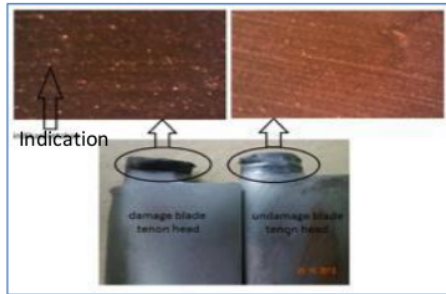
Figure 5 Crack on blade tenon head

and metallographic results showed corrosion on the surface of the shroud and blade tenon head. In addition to that, pitting corrosion and corrosion deposits is found on the bottom surface of the shroud and the joint area (figure 5 and 6) that have contact with blade tenon head is an evidence of corrosion attack that area. This corrosion attack and cyclic load lead to dimensional changes in the blade tenon that enlarge the gap and the relative movement that cause abnormal vibration. The combination of corrosion, worn-out blade tenon head, the influence of the bending load (unsteady steam forces, rotor torsion, radial vibration, axial vibration), the plant start-up and shut down process and steam conditions (pressure and temperature) cause the blade tenon head failure due to corrosion fatigue (Mc.Closkey, 1999). The presence of impurity in the vapor can accelerate corrosion rate and fatigue of blade tenon. The worn-out blade tenon head and the shroud is then broken that cause the shroud to detach from the turbine

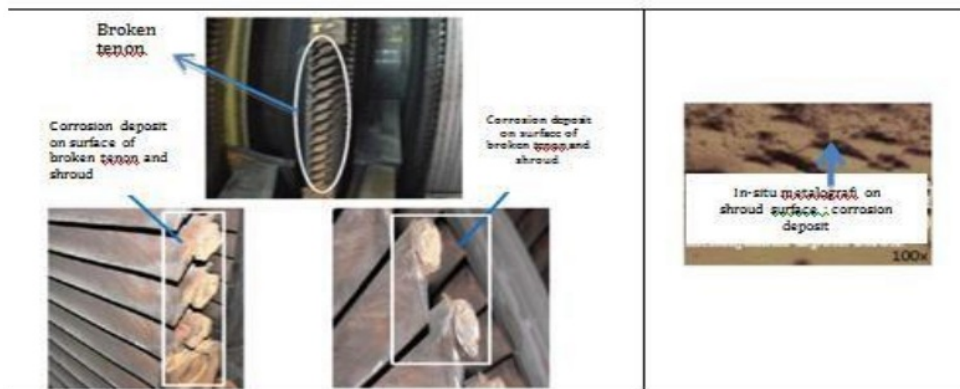
head found on the shroud broken part so that the upper surface of the shroud rubbing against the labyrinth experiencing great friction with labyrinth, blade which is justified by the indication of worn-out on overheating and subsequently ripped. shroud due to pitting corrosion and corrosion fatigue are typical of damage on steam turbine blade (Roberge, 2000), and has been widely reported in the literature / engineering paper (Mc.Closkey, 1999). Damage usually starts from localized corrosion caused by fretting, manufacturing defect, inclusion and pitting due to environmental factors such as the level of impurity steam, fault shutdown procedures, and the level of steam cation conductivity. A dewpoint lead the condensation process of the steam during shutdown process so that moist, liquid and oxygenated films formed on the surface of the blade and disc. A level of steam cation conductivity could accelerate that. Based on mechanistic models of corrosion fatigue, corrosive environments caused the vacancies as a result of dissolution phenomena on a metal surface (Mc.Closkey, 1999).

Image 5 Corrosion Tenon Blade Head

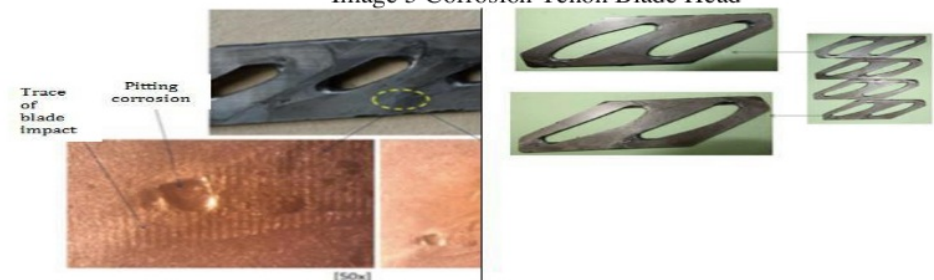
Figure 6 corrosion pitting on the surface of the bottom shroud

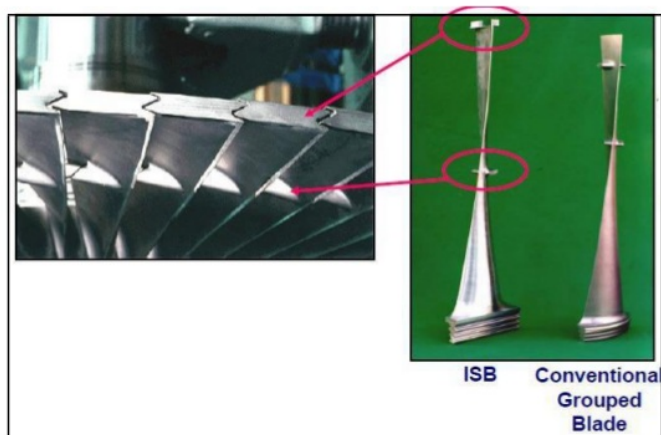
Figure 7 Integral Shroud Blade (ISB)

Turbine blades will be replaced with new design, Integral Shroud Blade (ISB) (Mitsubishi, 2009) (Figure 7). Its segment shroud has integrated profile with the blade so need no rivets or welding fastening process to reduce possibility of cracking due to residual stress, corrosion and fatigue. When the turbine reaches optimum operational rotational speed, shroud on adjacent blade will be aligned and strengthen themselves that give significant damping effect of the blade vibrations that reduce vibrations by 20% than conventional blade and increase blade reliability and corrosion fatigue resistance in corrosive environments of geothermal steam.
