Damage analysis of the forced draft fan blade in coal fired power plant

M. Nurbanasari*, T. Kristyadi, T.S. Purwanto, A. Maulana, R.R. Fadilah

ABSTRACT

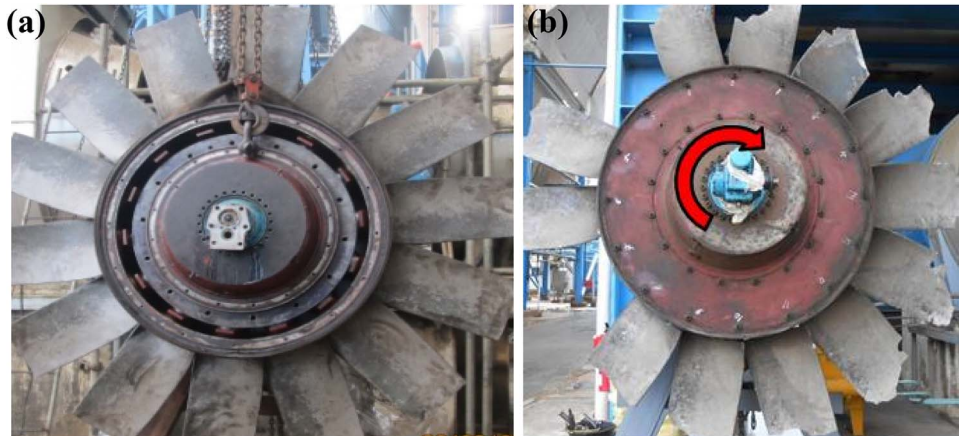
Fig. 1. Investigated FDF blades: (a) before failure and (b) after failure (red arrow indicates direction of rotation).

To define the cause of the damage, some methods consist of non-destructive and destructive examinations were carried out. Fig. 1 shows the FDF blades before and after failure.

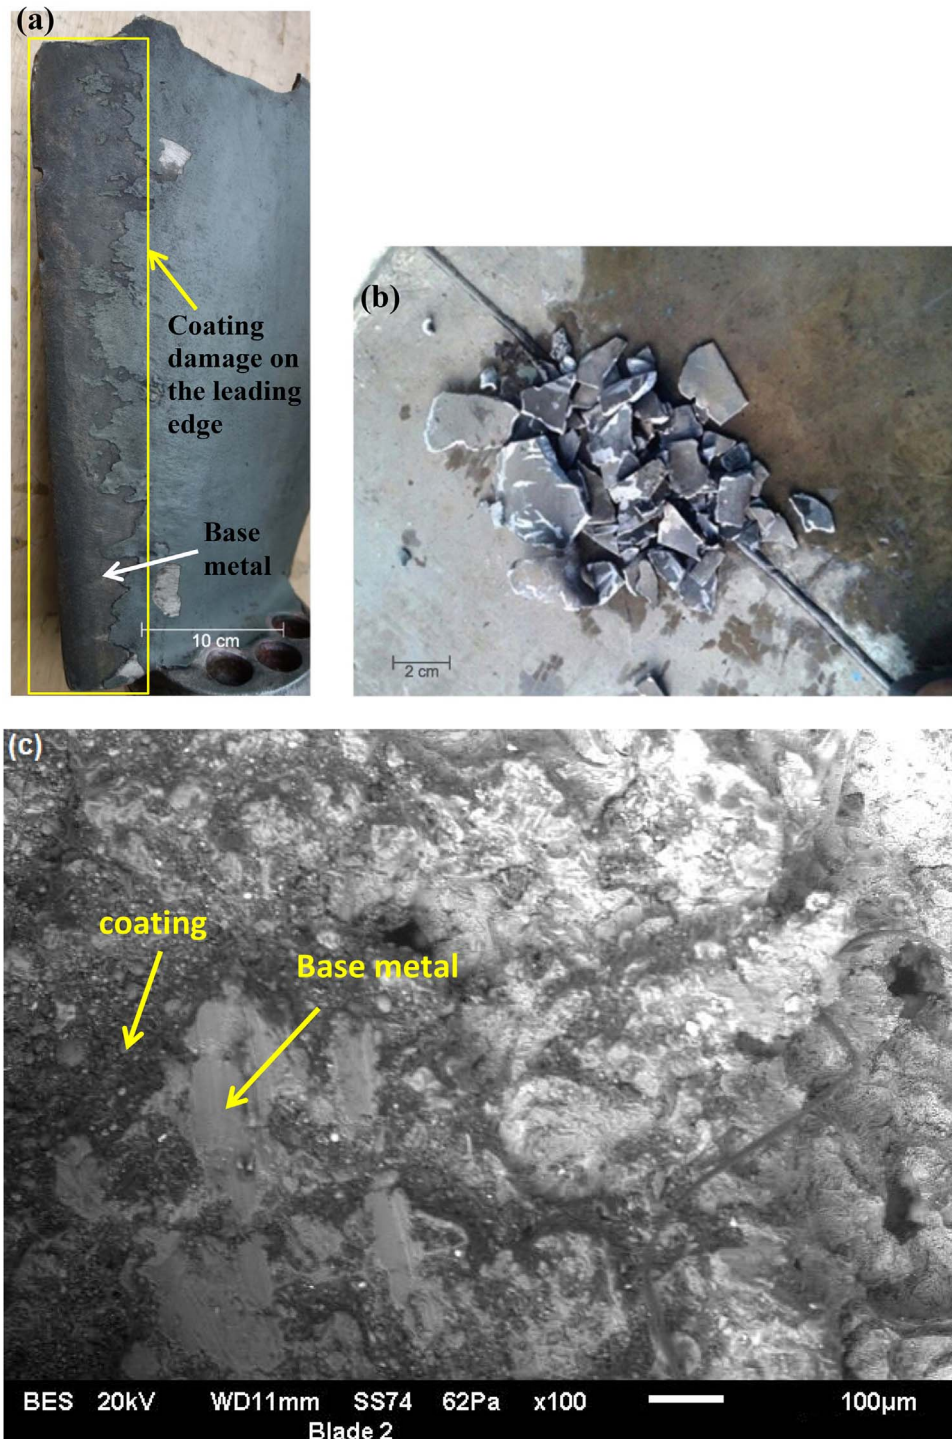
Visual inspection found that the coating of leading edge of the the blade had serious erosion damage, as can be seen in Fig. 2a and lots of debris had been collected behind the fan, including the heavily damaged blade itself. The debris of fractured blades was accumulated to support the analysis (see Fig. 2b). Fig. 2c shows the fractographs of damaged coating near to the leading edge of the blade. The coating of the blade has already lost and the base metal is clearly seen. Visual observation also found that there were two locations of damaged blade e.g., damage at the root of the blade and the other one is at the third of the blade height, as shown in Fig. 3.

Fig. 2. (a) Coating damage on the blade leading edge (indicated by square); (b) the debris of fractured blades and (c) a secondary electron image of coating damage area.

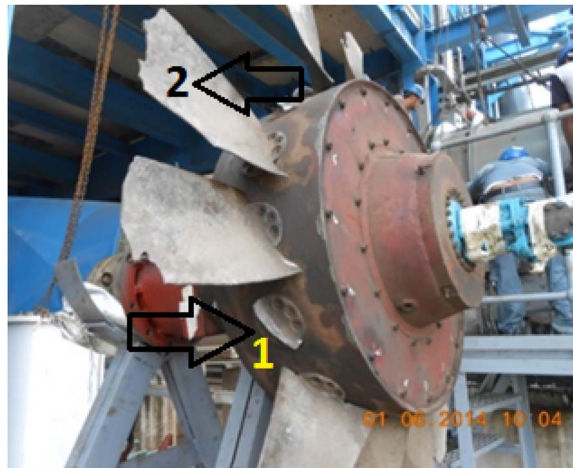
Fig. 3. Two locations of damaged blade: fracture at the root blade (shown by number 1) and fracture at the third of the blade height (shown by number 2).

The FDF blade was operated in clockwise at the rotation 1490 rpm and temperature 30 °C. The failure occurred at the root blade was actually caused by other blades' damaged on the body of those blades. The broken fragments of the blade entered in between casing (stator) and the blade (rotor) so they obstructed the blade rotation and causing a moment that resulted in a broken blade at the

- The failure of the root blade because of broken fragments of the others damaged blade entered in between casing (stator) and the blade (rotor) so they obstructed the blade rotation.

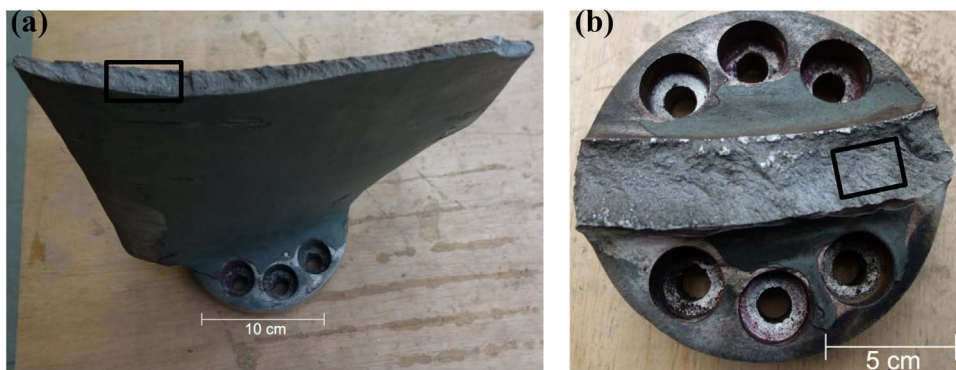
Fig. 4. The location of samples taken from the damaged blades (indicated by black square): (a) the third of the blade height and (b) at the root of the blade.

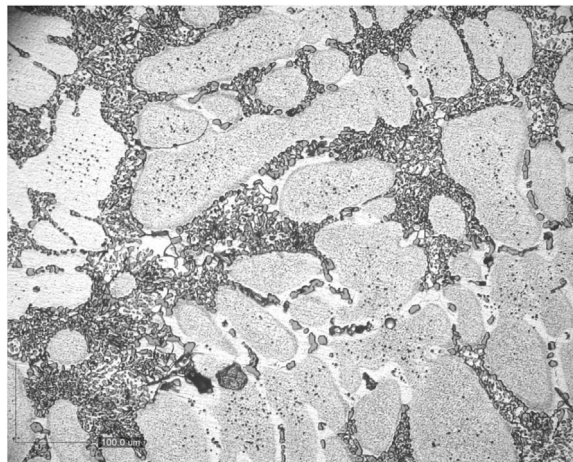
Chemical composition analysis of the investigated blade confirmed that the blade was made of aluminum alloy, which consists of 6.5% Si, 0.16% Fe, 0.8% Cu, 0.2% Mn, 0.3% Mg, 1.2% Zn (in %wt) and Al is balance. The chemical composition analysis of the debris was also in a good agreement with the materials of the damaged blade. The average hardness of the blade is 123.7 HV and the microstructure of damaged blade is shown in Fig. 5.

Fig. 5 shows the coarse microstructure consists of dendritic structure α -Al phase and associated segregation. The dendritic structures are surrounded by eutectic silicon and this is strong evidence that the blade was made by casting process. The cast alloys need to be well observed due to the defects formation during solidification process and the chemical composition of the alloys affect the mechanical properties [5]. There are some requirements for material to be used as FDF blade, e.g.: light weight, good wear resistance in high flow rate, good corrosion resistance and low maintenance. The application of aluminum cast alloy for the FDF blade is widely used in industry by considering that the characteristic of the aluminum alloys fulfill the requirements for the FDF [6]. Therefore, the use of Al-Si alloy for FDF blade in this coal fired plant met with the requirements. Referring to the results of the chemical composition, hardness and microstructure analysis of the blade, it can be concluded that the blade material is within the standardized cast Al-Si alloys (A356.0) and there was no indication of manufacturing defect, which contributed to the failure of the blade.

Fig. 5. An optical image of the investigated blade (hypoeutectic cast aluminum-silicon alloy).

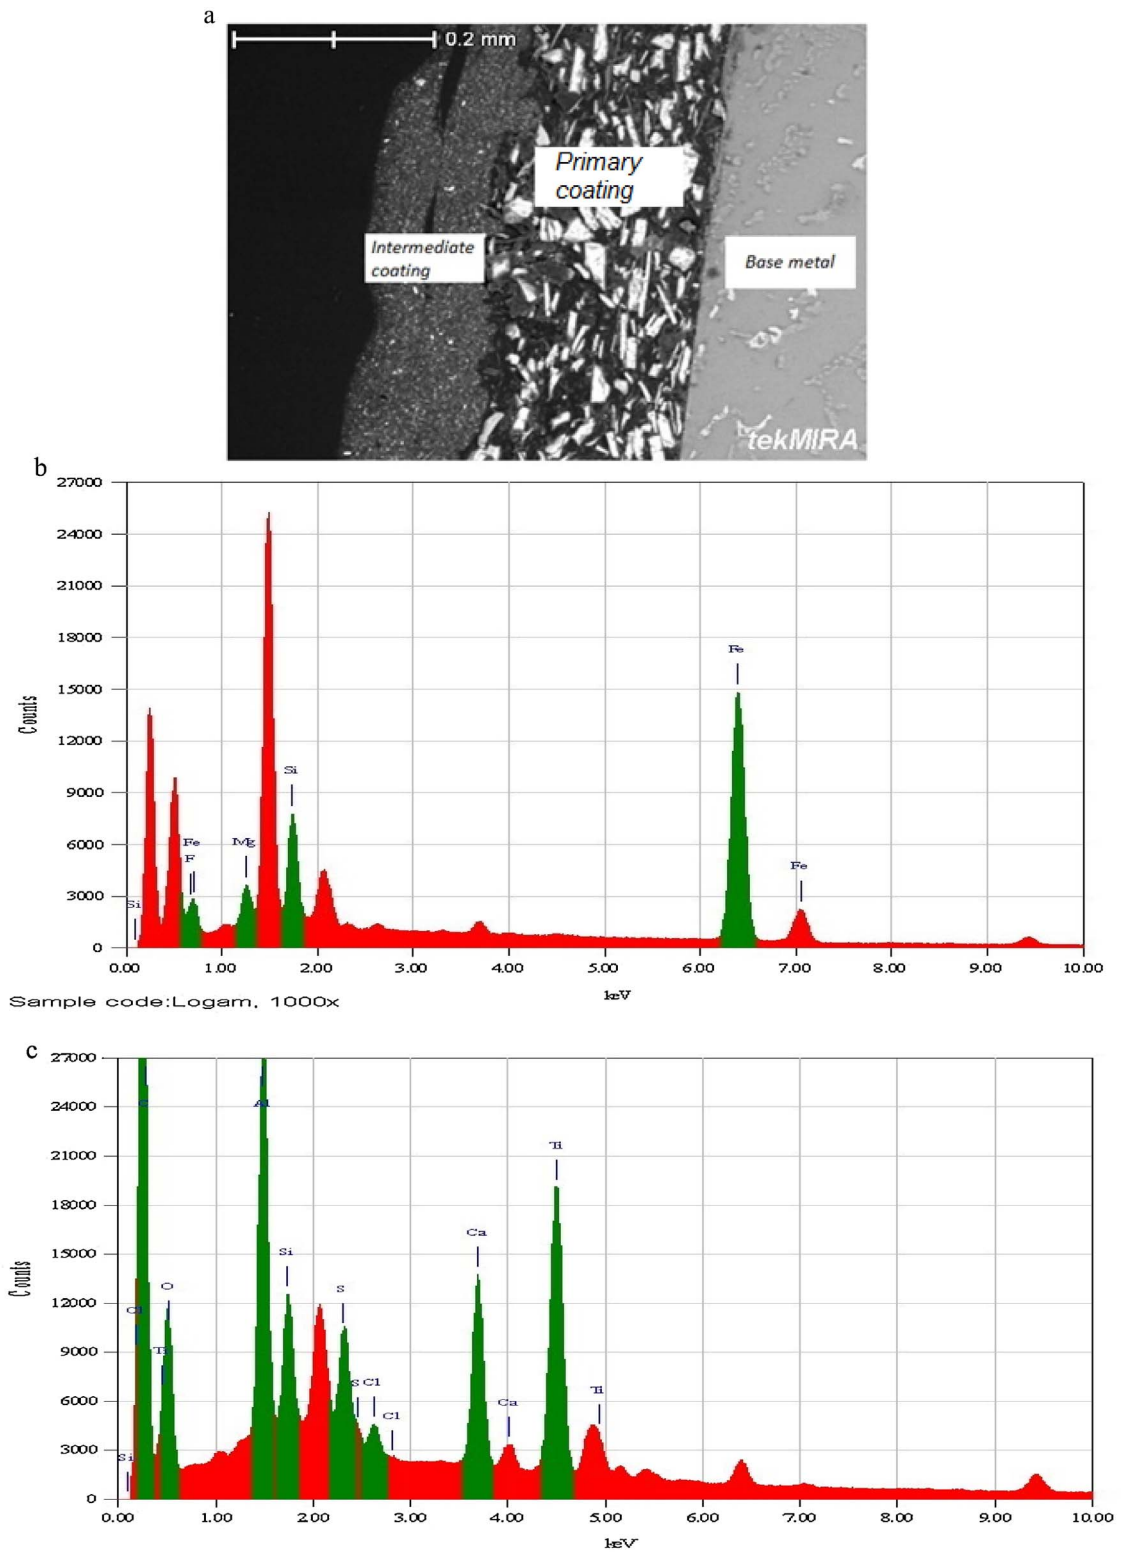
characteristic feature of the blade coating is coarse with different phases, which is shown by the microstructure contrast. Some discontinuities were found between the substrate and coatings. The EDS spectra of the coating blade (Fig. 6b and c) indicate that the primary and intermediate coatings contain Iron (Fe) and Titanium (Ti), respectively. The primary coating is thicker than the intermediate coating. In this case, the primary coating plays an important role to increase the corrosion resistance of the blade and the intermediate coating was applied to improve the resistance to erosion. The SEM studies exhibit that the coating blade (coating materials and their thickness) are appropriate for the FDF blade.

Fig. 6. a) A back scattered SEM image of the primary and intermediate microstructures of the coating blade. b) SEM-EDS spectra of the primary coating blade. c) SEM-EDS spectra of the intermediate coating blade.

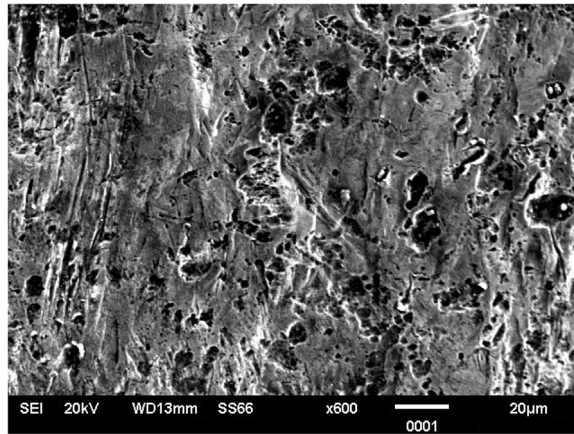
Fractography analysis using SEM was done on the surface of damaged blade and the result can be seen in Fig. 7

Fig. 7 shows that there are no beachmark and striations, which meant the failure of blade was not due to fatigue loading. The SEM image of damaged surface in Fig. 7 shows there are many porosities, which is typical of casting product and no evidence of prior plastic deformation. The brittle failure is supported by the debris of blade, which was broken down into pieces and no plastic deformation occurred (see Fig. 2b). SEM-EDS was performed on fractured surface of the damaged blade to study the deposit and the

Fig. 7. A secondary electron image of fracture damaged blade.

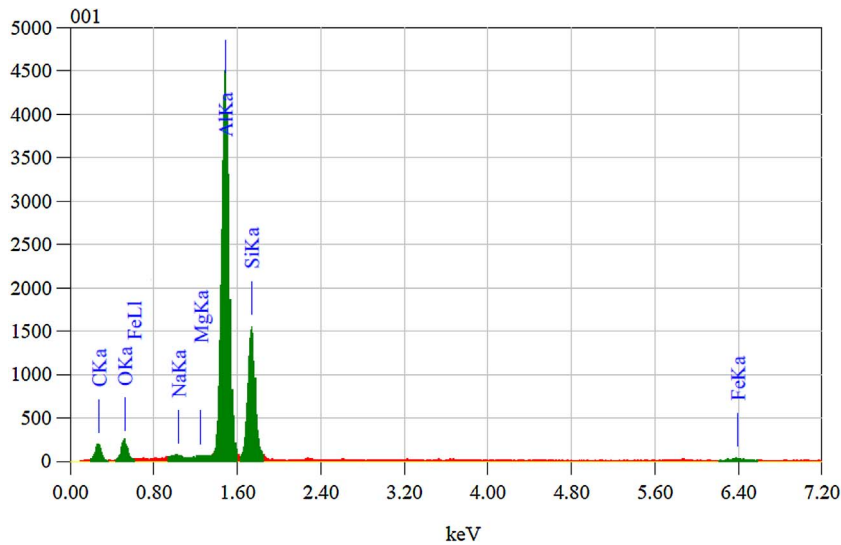
Fig. 8. SEM EDS qualitative analysis of coal fly ash on surface of damaged blade.

The SEM-EDS qualitative analysis of coal fly ash particles (Fig. 8) shows the presence of Carbon, Oxygen, Aluminum, and Silicon, and with low level elements of Sodium, Magnesium, and Iron. It means that coal fly ash particles were elementally composed of abrasive particles. The SEM-EDS result indicates that the damage at the third of the blade height was due to a possibility of entering external abrasive particles to hit the FDF blade. Collision of these external particles to the surface of the FDF blades caused erosion not only damage to the leading edge coating (see Fig. 2a) but also in the body of the blade. However the leading edge erosion occurred in all blades. This is due to the leading edge of the blade is the initial edge of the part of the blade that first contacts with the air [7]. Moreover the type of coal used in this power plant is high ash content low range coal (LRC), which produces large amounts of fly ash. Furthermore, the formation of fly ash is also the result as part of combustion process [8]. This is consistent with the findings on the surface of the blade with erosion and notch as can be seen in Fig. 9. The entering of fly ash that caused damage to the FDF blade was probably due to the filtration system did not work properly.

- The surface damaged of the blade was due to the external particle and based on SEM-EDS result, the external particle is fly ash, which probably came from the usage of low range coal and as part of combustion process.

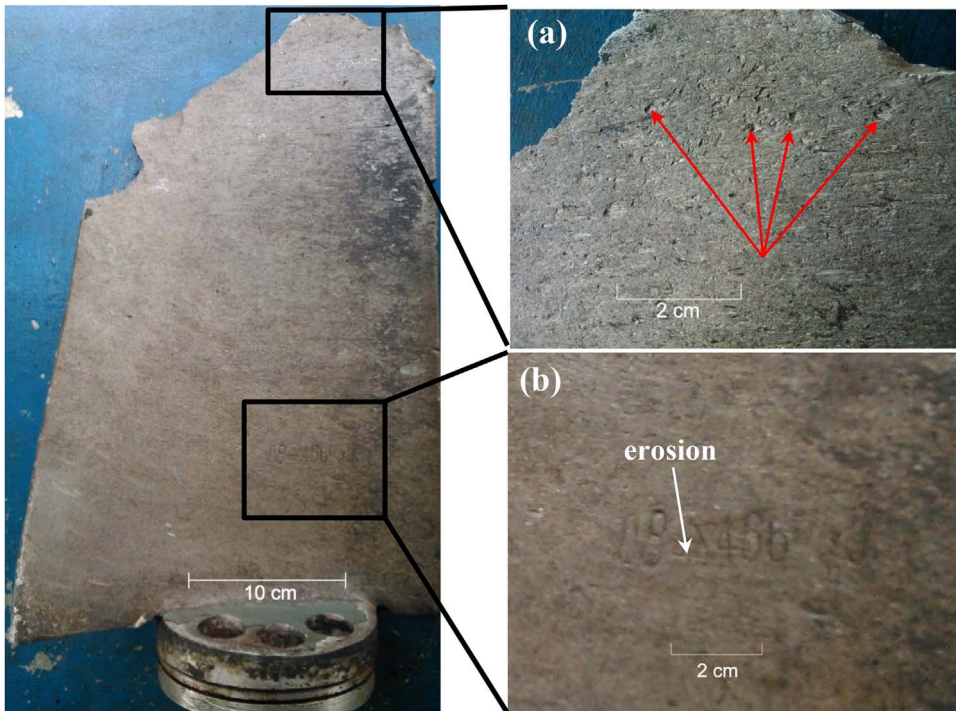
Erosion of FDF blade is characterized by the loss of blade material because of the mechanical action of particles in the air flow hitting or scratching on the blades surfaces. The influence of severe erosion brings about to extreme unbalance and high vibration. It has been reported that small particles with the size below about 10 microns do not have sufficient kinetic energy to cause blade erosion [9]. Thus in this failure of FDF blade was believed that the entering fly ash particle size was over 10 microns that less tends to stick on the blade surface, but they can cause erosion [8] and notch. Visual inspection found that there was notch that was formed near the leading edge of the damaged blade (see, Fig. 10) and experiencing crack propagation during the operation. This is not surprising, as mentioned before; the leading edge is the foremost part of the blade that first contacts with the air. That notch was probably the beginning of the heavy damaged of the FDF blades that were located at the third of the blade height blade. The notch acted as stress concentration and as well as the initial cracks. As the material of the blade is cast alloy that is brittle and very low toughness, the cast alloy of the blade can not withstand with the centrifugal forces caused by high rotation (1490 rpm) during the

Fig. 9. Surface damage of the investigated blade: (a) notch (indicated by red arrows) and (b) erosion.

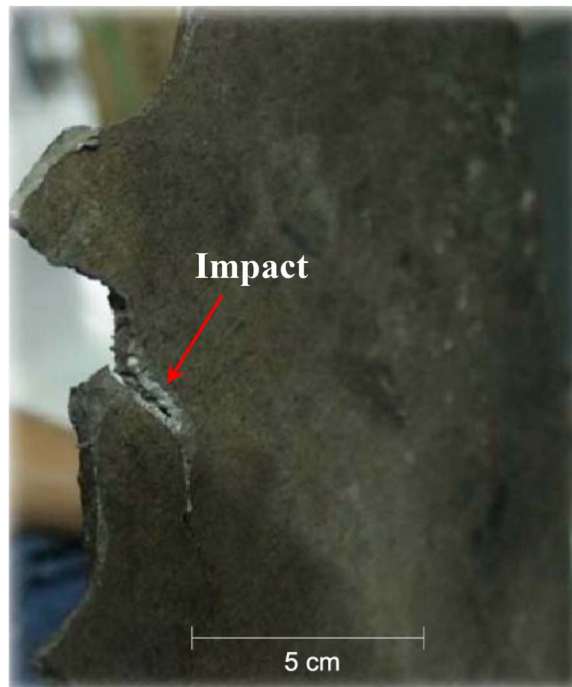
Fig. 10. Notch at the blade leading edge and proceed to crack propagation.

operation and led to rapid crack propagation occurs [4]. Hence, it is possible that any damages to one blade can cause multiple collisions to the other blades and as a result there were lots of debris.

- The failure of the third of the blade height because the external particles collide to the leading edge of the blades causing erosion and notch and the notch acted as initial crack. As the material of the blade was brittle and experienced high rotation causing the blade led to rapid crack propagation.
