The Centrum-Bandung : Adaptive Reuse at Heritage Building as Sustainable Architecture

Abstract. Historic buildings which are the remains of the Dutch Colonial period from the glorious past era still exist in some cities in Indonesia. These buildings can be easily recognized from their typical architectural style in which a mixture of European architecture adjusted to the country's tropical climate known as Indische Architecture. The style is obvious in parts of the cities in which the Dutch carried out their activities such as districts for offices, trading centres, housing complexes as well as recreational areas. One colonial building in Bandung infamously implementing the style is The Centrum. The building which originally functioned as a recreational vicinity was built in 1920s. Designed by C.P. Wolff Schoemaker, it served as swimming pool or bathhouse where the people of Dutch residing in or visiting the city spent their leisure time. The Centrum, of which facilities the Indonesian in the colonial period were prohibited to even used, has become a cultural heritage landmark located in historic military base. A cultural heritage should be conserved to preserve the valuable gener

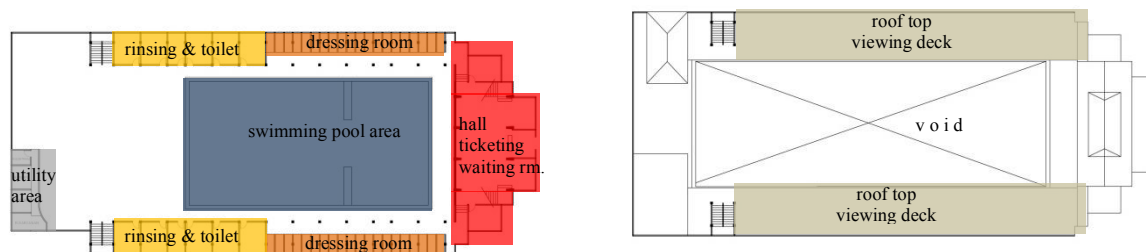
The main building served function as a reception area consisting of a ticket window, a food counter, two stairs leading to the 2nd floor, a waiting room and a sitting room leading to the swimming pool. The supporting buildings also consisted of 2 floors, the 1st of which served as area for dressing, rinsing and utility while the 2nd of which in the form of a roof top functioned as sitting area that had direct view towards the swimming pool. The size of the dressing room and the rinse area is 1 structural grid divided into 3 rooms (**Figure 2.**).

Figure 2. The Blueprints of the 1st and 2nd floor of The Centrum Bandung (1920-2000)
(Source : interview, Tirtamerta, 2017, edited)

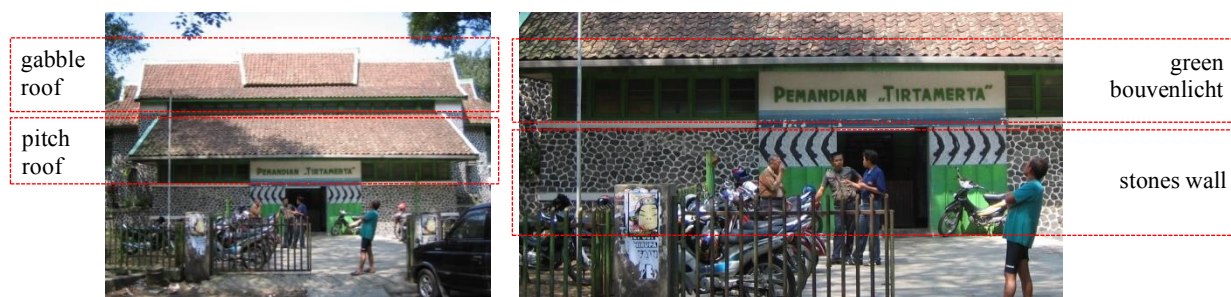
The Centrum's main building implemented a combination of roof constructions. The entrance applied half-saddle roof (pitch roof), the inner of the main building was topped by a julang-ngapak style roof (gabble roof) covered with tiles made of clay. The facade of the principal front of the building was dominated by stones painted black and was crowned by skylight (bouvenlicht) made of transparent glass using wood painted green as the frame (**Figure 3.**).

Figure 3. The Façade of the Outside of The Centrum's Main Building (1920-2000)
(Source: <http://2.bp.blogspot.com/>, retrieved 17 Oktober, 2017,edited)

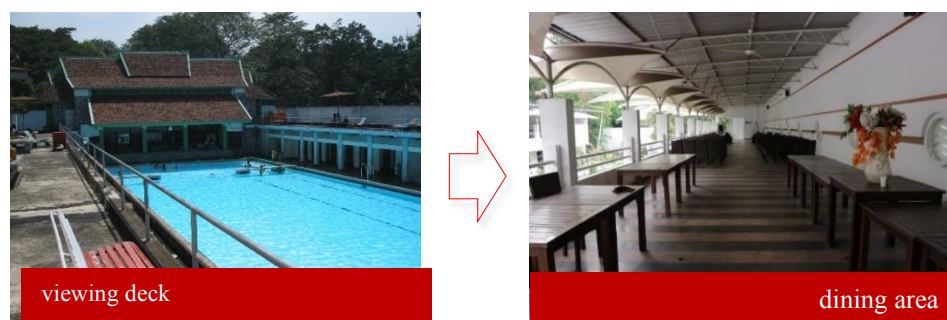
The façade of the principal front building had also followed the change by the addition of a terrace at the main entrance equipped with a concrete portal and natural sandstone from the city of Jogja combined with walls painted blue. The black painted river stones functioned as the cover of brick wall were still preserved while the originally green skylight wooden frame was then painted white. The material of the roof tiles which had initially been clay was replaced with ceramic, considering that the character of a building must not change even though changes are made to the building in question. The changes occurred to the supporting buildings were the transformations of rinse areas, toilets and changing rooms into dining area for sitting on the floor style, VIP dining area, beverage counter, toilets, stairs to the 2nd floor, and utility area. The 2nd floor of the building which was originally a roof top provided for gathering area was turned into an open plan dining area that had multi-functional use (**Figure 4**).

Figure 4. The Blueprint of 2nd Floor and the Changes of Room Functions at The Centrum's Supporting Buildings at the 2011-2018 Period
(Source: Bandung Heritage, 2017, edited)

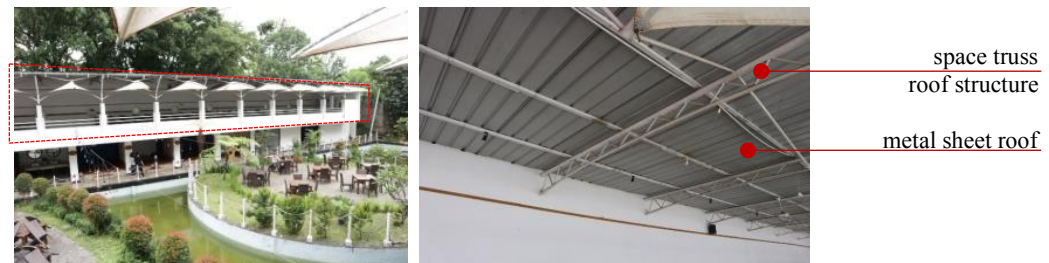
The supporting buildings which in the previous period were without barrier, in this period were enclosed by a combination of metal sheets and membranes for the roof. The metal roofing sheets were supported by truss frame which also functioned to hold the membranes of the tent roof firmly in place. Therefore, a column structure was added on the 2nd floor. The façade of the supporting buildings was a white painted brick wall equipped with fixed circular glass windows (**Figure 5.**).

Figure 5. The Roof's Metal Sheets and Membranes of the 2nd Floor of The Centrum's Supporting Buildings at the 2011-2018 Period
(Source: Survey and research result, 2017)

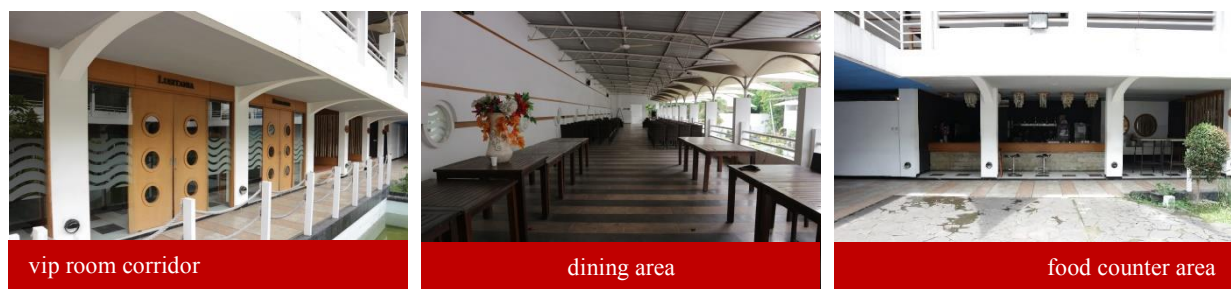
Meanwhile, at the ground floor there was a repetition of circular glass on the doors of the VIP rooms as well as other spaces. Railing made of ropes separated the ground floor's corridor area from the pool area (**Figure 6.**).

Figure 6. The Façade of the Centrum's Supporting Buildings at the 2011-2018 Period
(Source: Survey and research result, 2017)

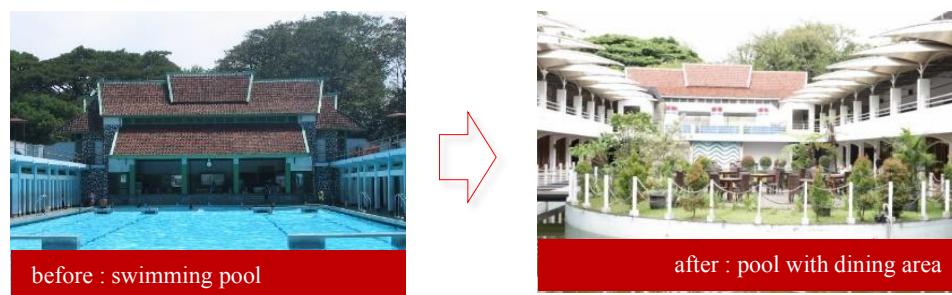
Transforming the function of the swimming pool into ornamental pond was executed by backfilling the floor level. A wedding venue in form of plaza/courtyard covered with natural stone material was placed in the middle of the pool area. The other function of the plaza beside as a wedding venue was as an outdoor dining area surrounded by vegetation and railing made of iron and rope (**Figure 7.**).

Figure 7. The Transformation of Swimming Pool into Ornamental Pond The Centrum at the 2011-2018 Period (Source: Survey and research result, 2017)

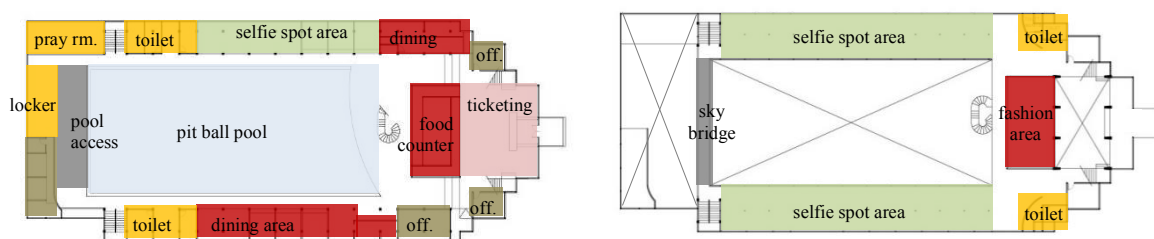
In 2018, The Centrum was turned into a tourist destination by becoming a selfie spot to attract tourists, called the Centrum Million Ball. This new function adapted to today's tourism needs. The change in function of course has given impacts on some architectural layouts and structures (**Figure 8**).

Figure 8. Blueprint of the Building's 1st Floor (left) and 2nd Floor (right)
The Centrum at the 2018-present period (Source: Survey and research result, 2019)

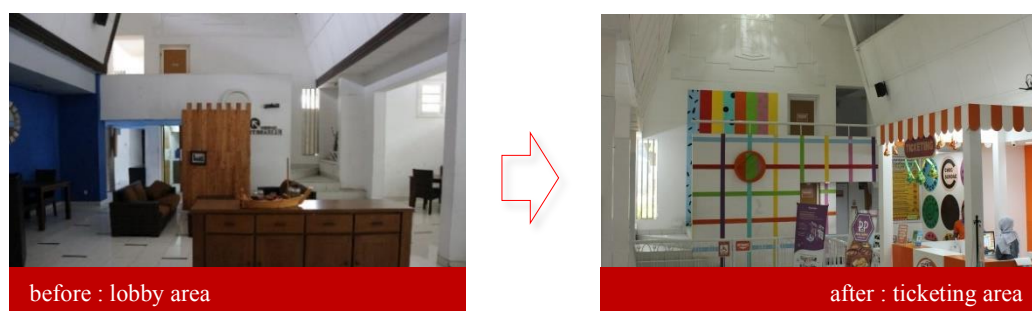
The changes to the main building among others was the transformation of the restaurant's lobby into a ticket booth, and the previously large kitchen room into a souvenir area (**Figure 9**).

Figure 9. The Transformation of Façade & Rooms of the Main Building
(Source: Survey and research result, 2019)

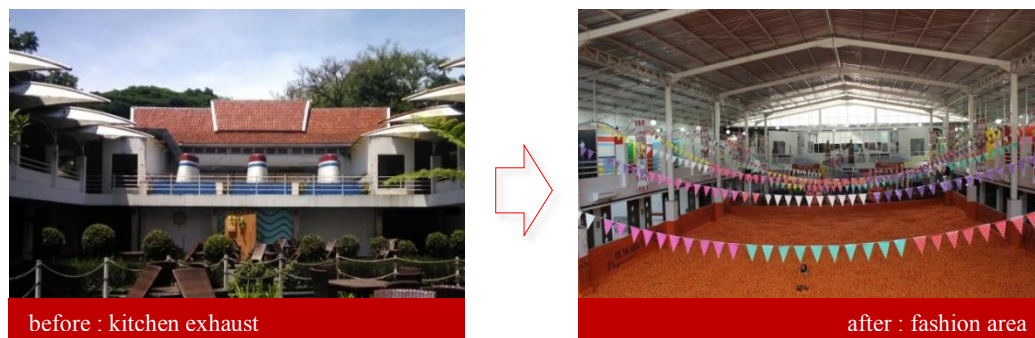
The exhaust fans resembling ship funnels, located on the 2nd floor when the building functioned as a restaurant & wedding venue, was then turned into a commercial area equipped with a swivel staircase to give access to the upper floor. The staircase was painted with contrast colours overlooking ball pit pool area (**Figure 10**).

Figure 10. The Transformation of the Façade of the Pool Side of the Main Building of The Centrum Bandung (Source: Survey and research result, 2019)

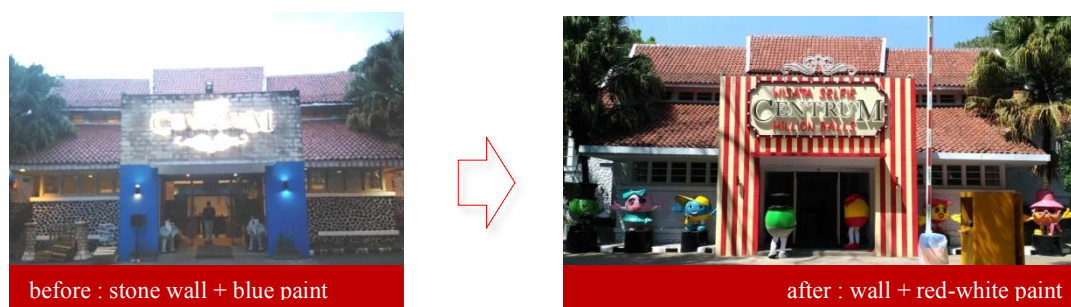
The transformation of the facade of the main building was slightly occurred in the principal front especially at the building entrance. The stone walls at the west and east of the entrance were painted white while the entrance area, which was originally a wall made of natural sandstone from Jogja, was painted with contrast colours designed to attract visitors' attention (**Figure 11.**).

Figure 11. The Facade of the Outer side of the Centrum's Main Building (2018-present) (Source: Survey and research result, 2019)

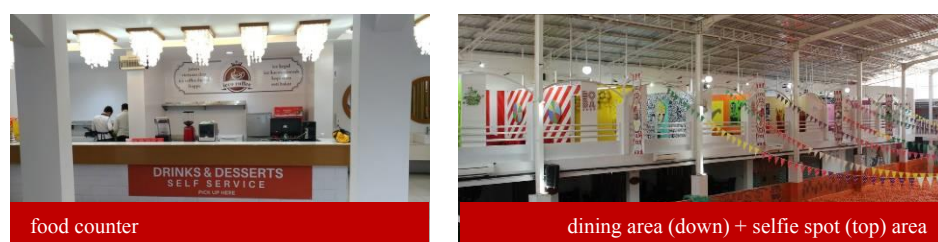
The function and architecture layout of the 1st floor of the supporting buildings have not experienced prevalent changes i.e. as a sitting/dining area, food counter and toilets. Similarly, at the façade some elements of the walls, columns and doors from the time when the building functioned as a restaurant & wedding venue are still used similarly even it has become a selfie spot. A quite major transformation was carried out on the 2nd floor, where the function of the open plan dining area has turned into a thematic selfie area with a variety of colours applied to each modular structure. The food court area, however, remains in the similar place as it was in the previous function on the 1st floor with a slightly different interior design (**Figure 12.**).

Figure 12. The Transformation of the Facade and Function at the East Wing of the Supporting Buildings (Source: Survey and research result, 2019)

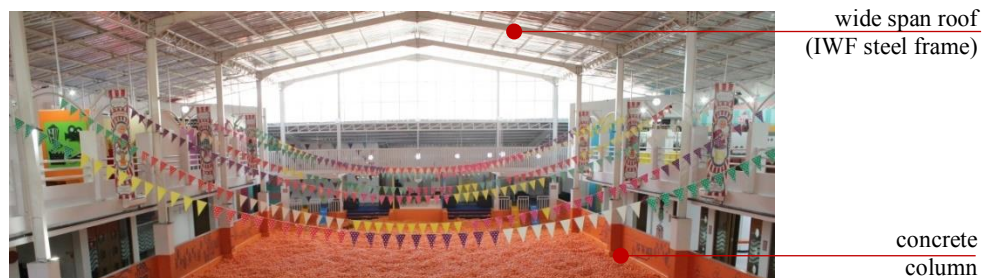
The ball pit pool area along with the second floor of the supporting building are topped by a wide span roof making use of metal sheets supported by IWF steel frame. The old structure columns are still retained and now serve to support the wide span roof. All of these changes have made the Centrum Million Ball an indoor tourist spot. Based on regulation No. 19, 2009 in the efforts of rehabilitation and revitalization, changes in functions and inner layout are made possible provided they do not alter the character of the main structure of the building. In this regard, the change in the function of the Centrum Million Ball does not alter the character of the main structure of the supporting buildings, but alter the overall character in a way that the pool area which was initially outdoor becomes indoor with its wide span roof (**Figure 13.**).

Figure 13. The Addition of Wide Span Roof
(Source: Survey, 2019)

The transformation in the pool area occurred on the ornamental ponds which have turned into a ball pit pool. This pool can be used as one of the visitor's photo / selfie areas. The ball pit pool is surrounded by ± 1.2 -meter-high wall to keep balls from bouncing into the dining area and corridor. The ball pit pool can be accessed using the stair straps as well as slides for children at the south side of the site.

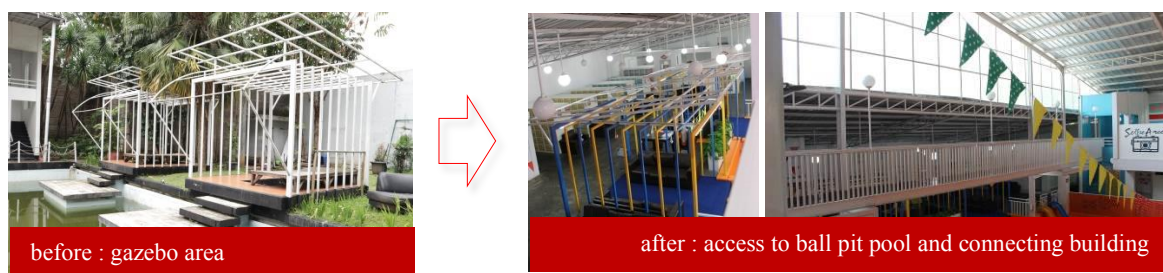
The gazebo area has turned into a corridor connecting the supporting buildings and the ball pit pool and was constructed into 2 floors, on the 2nd of which railing is placed along the end side bordering it to the pool area. Referring to Article 22 City of Bandung Local Regulation No. 19, 2009 about Criteria, Classification and Restoration of Cultural Heritage, that on parcels or building areas of cultural heritage it is possible to construct additional buildings attached to the main building as a unit, the connecting building is still in harmony with other buildings (**Figure 14.**).

Figure 14. The Addition of Funtion at the South Area of th Site
(Source: Survey and research result, 2019)
