# The Transformation of Heritage Buildings as Tourist Attraction :

## Adaptive Re-use of Colonial Buildings at a Bandung Conservation Area

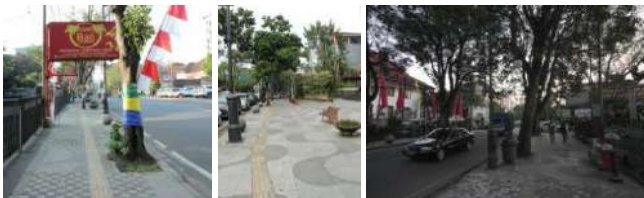
Fig. 5 : The present condition of the pedestrian sidewalks

To restore the pedestrian function, in 2016 the Local Government revitalized the pedestrian sidewalks. The physical improvement were performed by widening the lane and culverts. Some street furniture such as benches, trash cans, bollards, street lights, signage, bicycle racks and greeneries have also been added to make the pedestrian sidewalks beautiful and comfortable.

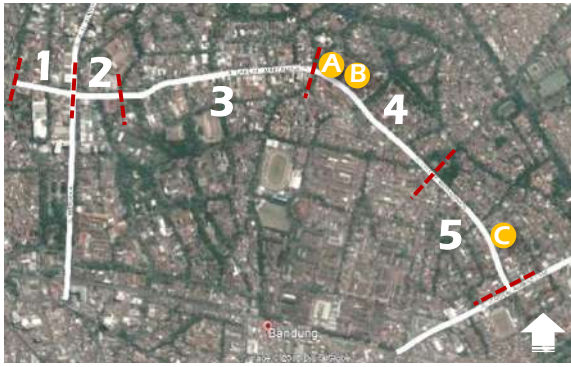
Fig. 13 Location of Case Studies

To discuss the physical appearance of the buildings on Riau Street, we have chosen three cases of building alterations. Figure 13 shows the location where the cases are located.

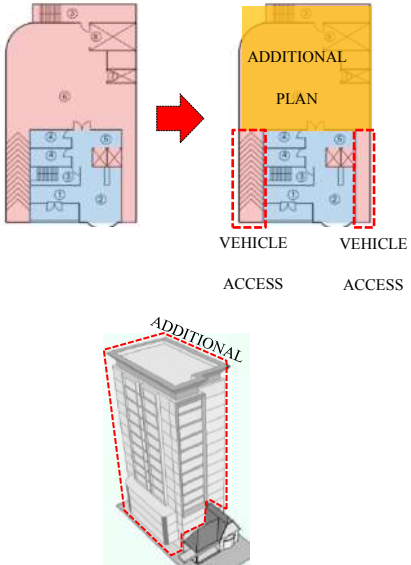
TABLE VI. TEBU HOTEL CONDITION

Tebu Hotel was built on a 1.631 m<sup>2</sup> land. The original building is remained only at the front side with the size of approximately 306 m<sup>2</sup>. This remaining structure is currently used as the lobby and reception of the hotel.

The rear part of the original building had been demolished and then built a new 7 floor building. The first three floors are used as parking areas, while the rest four floors are used for hotel rooms. There is a swimming pool on the rooftop as another facility offered by the hotel. The summary of information regarding Tabu Hotel is shown in Table VI below.

| Previous Condition | Present Condition |
|---|--|
| <ul style="list-style-type: none"> <li>▪ Ramp at the left side used as vehicle access</li> <li>▪ Parking area at 3 first floors the rest floor used as hotel room</li> <li>▪ Swimming pool located at roof top</li> </ul> | |
