# Performances of Long-term Coastal Field Aged Silicone-coated Ceramic Insulators under Clean and Salt Fog Conditions

Dini Fauziah\*, Heldi Alfiadi, Rachmawati, Suwarno

School of Electrical Engineering and Informatics  
Institut Teknologi Bandung  
Bandung, Indonesia

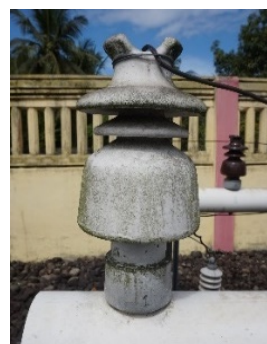
a. Coated insulator

b. Uncoated insulator

Fig 1. Coated and uncoated insulator conditions after 5 years and 4 months aging in the field

Fig 1 shows coated and uncoated insulator conditions after 5 years and 4 months aging that used as tested samples in laboratory, while Fig 2 shows configuration of insulators where aging was conducted along 5 years and 4 months.

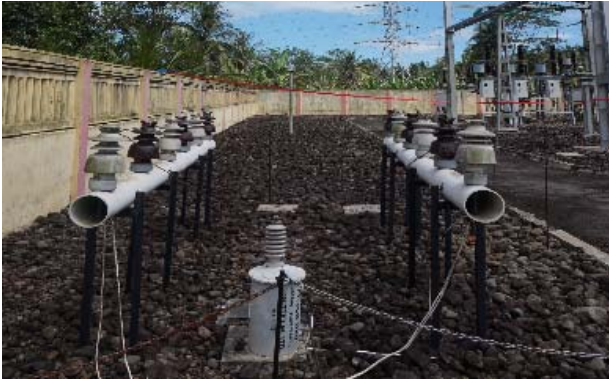
Fig 2. Configuration of insulators aging at coastal area

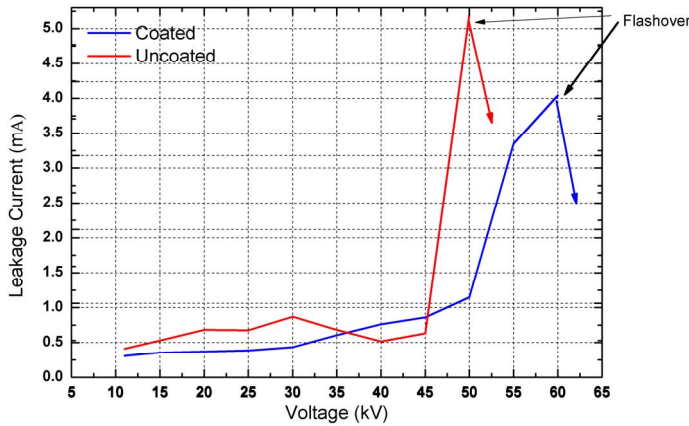
Fig 6. Dependences of leakage current magnitude of coated and uncoated insulators on applied voltage under salt fog condition

Fig 6 shows comparison of leakage current magnitude of coated and uncoated insulators under salt fog condition. Leakage current magnitude of coated insulator under salt fog condition was increased continuously until flashover occurs at 60 kV while uncoated insulator was flashover at 50 kV with fluctuative leakage current magnitude especially when magnitude decrease at voltage 35 kV and increase at 45 kV.

Under fog condition, leakage current magnitude increase with fog conductivity. Compared to the leakage current magnitude under clean fog, the leakage current magnitude under salt fog was much higher than those from clean fog. At clean fog condition, the leakage current magnitude

increased linearly with the applied voltage while at high fog conductivity the oscillation behaviour of leakage current magnitude dependence on applied voltage was observed due to the wetting effect of sample surface by the fog and drying effect caused by the higher leakage current [10]. The high magnitude of leakage current in turn will heat the insulator surface and may promote the degradation of the insulator.

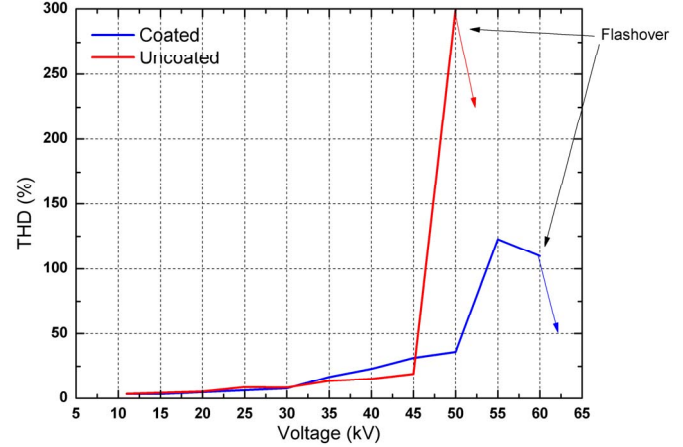
Fig 7. Dependences of leakage current THD of coated and uncoated insulators on applied voltage under salt fog condition

Fig 7 shows comparison of leakage current THD of coated and uncoated insulators under salt fog condition. THD of leakage current under salt fog condition has the same trend with the magnitude which THD of coated and uncoated insulator increased continuously until flashover occurred. But when applied voltage was 60 kV for coated insulator, the THD decreased before flashover because the magnitude was very high while harmonic content increase not so high so ratio of them was smaller at that condition.

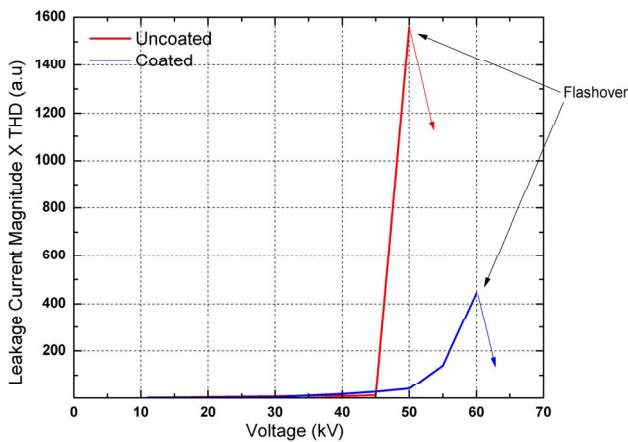
Fig 13. Dependences of cross product of leakage current magnitude and THD of coated and uncoated insulator on applied voltage under salt fog condition

Fig 13 shows cross product of leakage current of coated and uncoated insulator under salt fog condition. Under salt fog, both of insulators exposed to flashover with coated insulator has higher flashover voltage that uncoated insulator. From Fig 13 we can see that coating can improve ceramic insulator performance when it exposed to severe condition with high humidity and high fog conductivity. The flashover occurrence showed in Fig 14. Coated insulator exposed to flashover at voltage 60 kV while uncoated insulator at 50 kV.

At salt fog condition with conductivity 51 mS/cm, uncoated insulator flashover at voltage 50 kV while coated insulator flashover at voltage 60 kV. It shows that with RTV silicone rubber coating, flashover voltage of field aged ceramic insulator was increased, so it can be a good recommendation to use the coating for ceramic insulator which applied in coastal area with high pollution and high humidity condition.

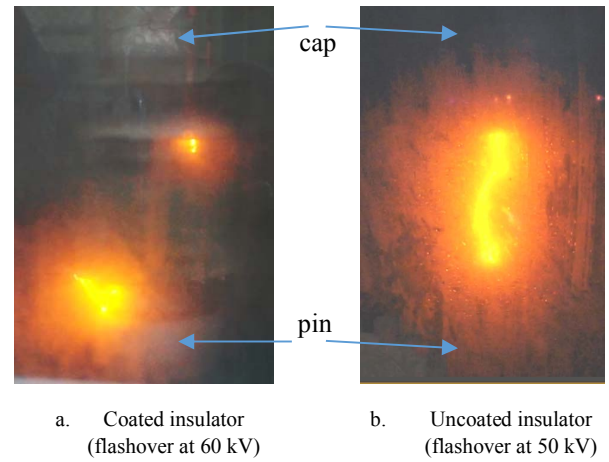
Fig 14. Insulator condition while flashover occurs
