# *The Effect of Coating on Leakage Current Characteristic of Coast Field Aged Ceramic Insulator*

Dini Fauziah\*, Heldi Alfiadi, Rachmawati, Suwarno  
School of Electrical Engineering and Informatics  
Institut Teknologi Bandung  
Bandung, Indonesia  
\*dini\_fauziah24@yahoo.com

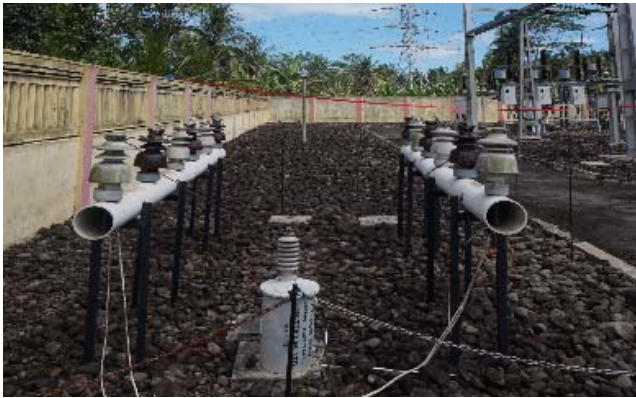
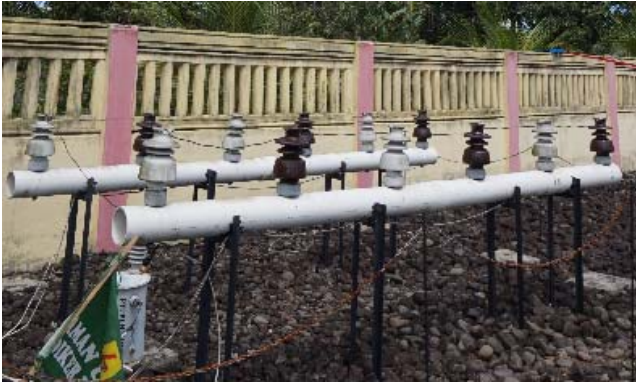
Fig 1. Configuration of insulators aging at coastal area

The insulators were installed in the switchyard area and powered continuously along aging process as shown in Fig. 1. The insulators were produced by PT Twink Bandung, Indonesia with creepage distance of 500 mm. The insulators are widely used in Indonesian State Electricity Corporation (PT. PLN) network.

a. Front view

b. Side view

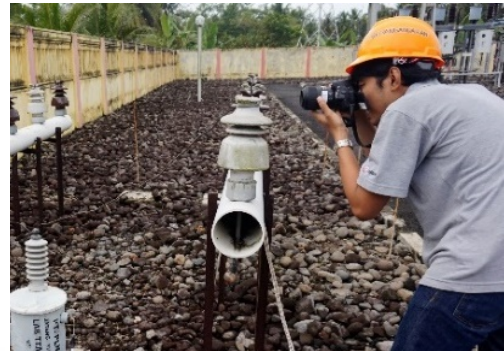
Fig. 2. Hydrophobicity capturing

Hydrophobicity of insulator might be a good parameter to know insulator surface condition of water repellency because it can be a cause of dry band. Hydrophobicity is indicated by its contact angle. Hydrophobic surface has contact angle more than 90° while hydrophilic less than 90°. Hydrophobicity was measured by dropping 50 µl water to the insulator surface and then it was captured 2 minutes after the water drop by Sony digital camera with macro lens to see the degree of hydrophobicity. Fig. 2 showed capturing process of the dropped water at insulator surface with distance about 15 cm between camera and insulator surface. The position angle of capturing must be equal with insulator surface to simplify measurement process. After the surface was captured, the contact angle was measured using protractor.

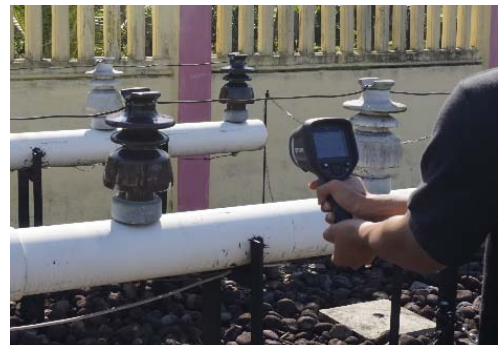
Fig. 3. Surface temperature capturing

Besides contact angle, surface temperature measurement can represent insulator surface condition due to the impact of coating to ceramic insulators. The insulator surface temperature was measured using Flir Infrared camera E4 type by capturing desired spot of insulator. The Flir camera has IR resolution 80 × 60 pixels with object temperature range about -20°C to +250°C and accuracy ±2°C. Fig 3 showed capturing process of insulator surface temperature. The distance between Flir camera and the insulator was about 30 cm and spot of the capturing process was depend on which surface temperature spot that we want to measure. Both contact angle and surface temperature capturing process must be done under power off condition for safety measurement.

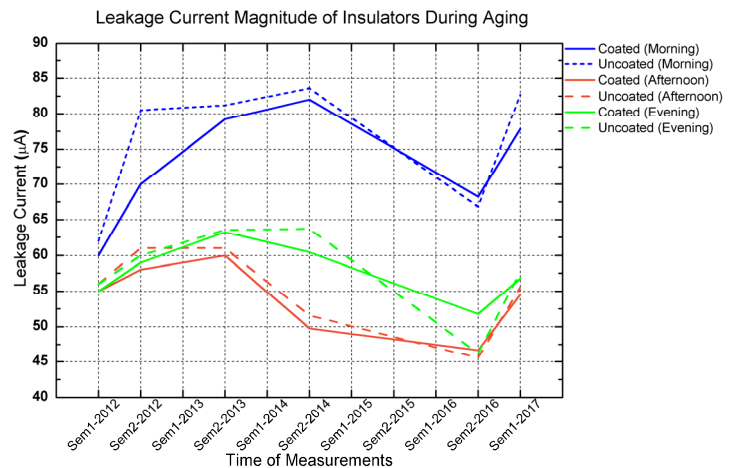
Fig. 5. Leakage current magnitude of insulators during aging

Fig. 5 shows that leakage current magnitude has small increase along time, except for 2<sup>nd</sup> semester of 2016 measurement. The difference was occurred due to different environmental condition when measurement conducted. Leakage current magnitude will different between rainy and dry season, it was because environment self-restoring. However along measurement conducted, the difference was not significant. The highest leakage current magnitude at first measurement was 62  $\mu$ A while at last measurement after 5 years and 4 months aging it was 82  $\mu$ A, so the aging still has small impact to the leakage current magnitude.

The result showed that highest leakage current magnitude was measured in the morning when humidity was high. It shows that humidity degree has high impact to leakage current magnitude. However with silicone rubber coating, ceramic insulator has better performance to suppress leakage current magnitude. The low leakage current corresponds with high surface resistance which indicates that both coated and uncoated insulators still in healthy condition after 5 years and 4 months aging at coastal area. THD value of leakage current was showed in Fig. 6.

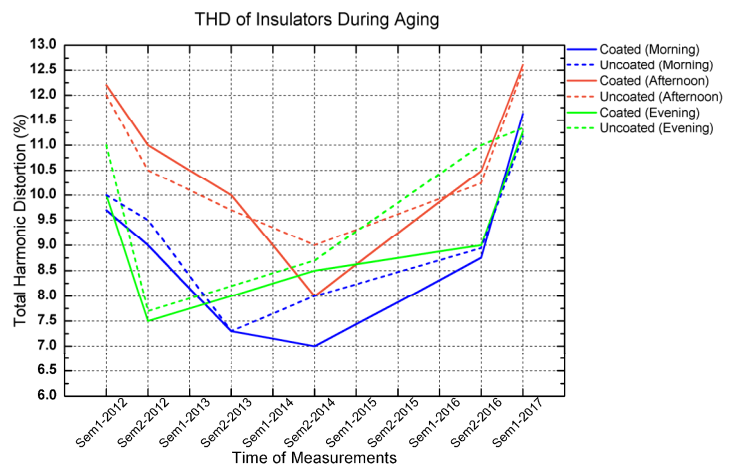
Fig. 6. THD of insulators during aging

Fig. 6 shows that THD value was increase and decrease due to different surface condition. As explained before, the insulator has environment self-restoring. When insulator was exposed by rain, the rain washed insulator surface so THD value was lower while if rain was not occurred, pollutant will collected at the surface and caused THD value higher. The THD value also affected by leakage current magnitude, because the higher leakage current magnitude will rise its fundamental value so total ratio of the harmonic components and the fundamental will decrease. The result showed that the THD value highly affected by pollutant distribution at the insulator's surface and also by magnitude of the leakage current.

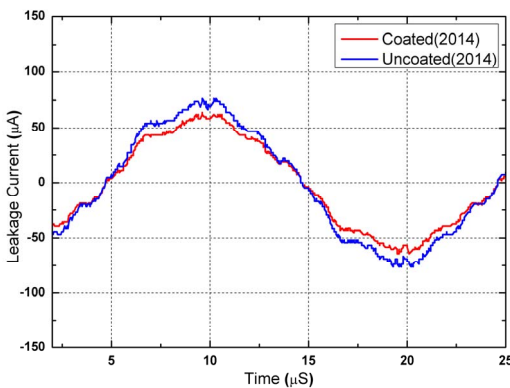
Fig. 7. Comparison of leakage current waveform at different measurement time

The THD value was represent how distorted leakage current waveform by harmonic content which caused by pollutant. Along aging time, leakage current waveform has changes. Fig. 7 shows typical waveforms taken from both coated and uncoated insulators at morning time to show the changes.

a. 2012 measurement

b. 2014 measurement

c. 2016 measurement

d. 2017 measurement

As shown in Fig. 7, there were comparison of leakage current waveform at different measurement time with coated insulator was red and uncoated insulator was blue sign. Harmonic content of leakage current waveform has changes along the years, but still in small turn with 5<sup>th</sup> dominant harmonic appear. Besides it, along long-term aging small arc arise and caused peak form of the wave was changed.
